Friends Meeting House, Alston

Front Street, Alston, CA9 3HP

Statement of Significance

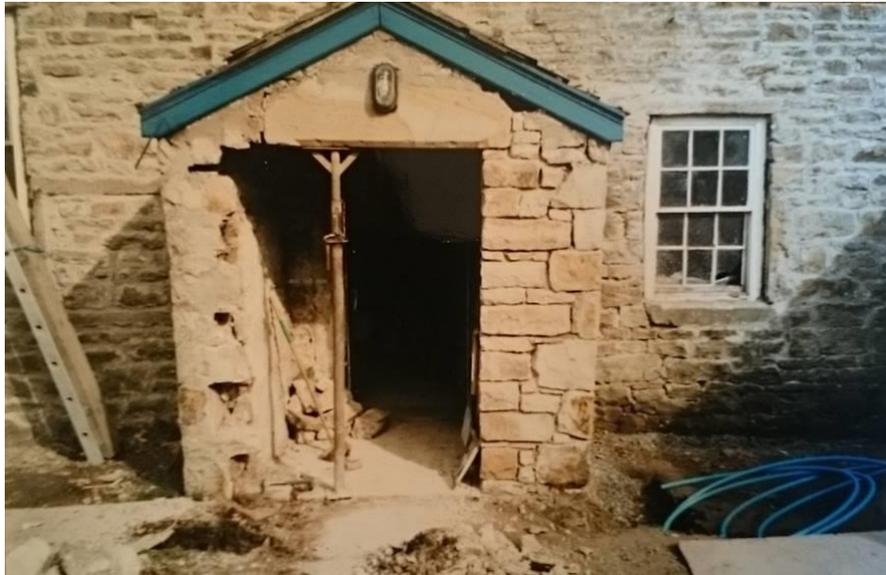
Figure 1: External repair works 1996/1997 (Alston FMH archive)

Friends in Alston began to meet again in 1972 as a result of new Friends moving into the area. In 1996 the building was refurbished with external repairs (Fig.1) and new toilet and kitchen facilities added in the former women's meeting room. The work was managed by Peter Kempsey of Countryside Consultants.

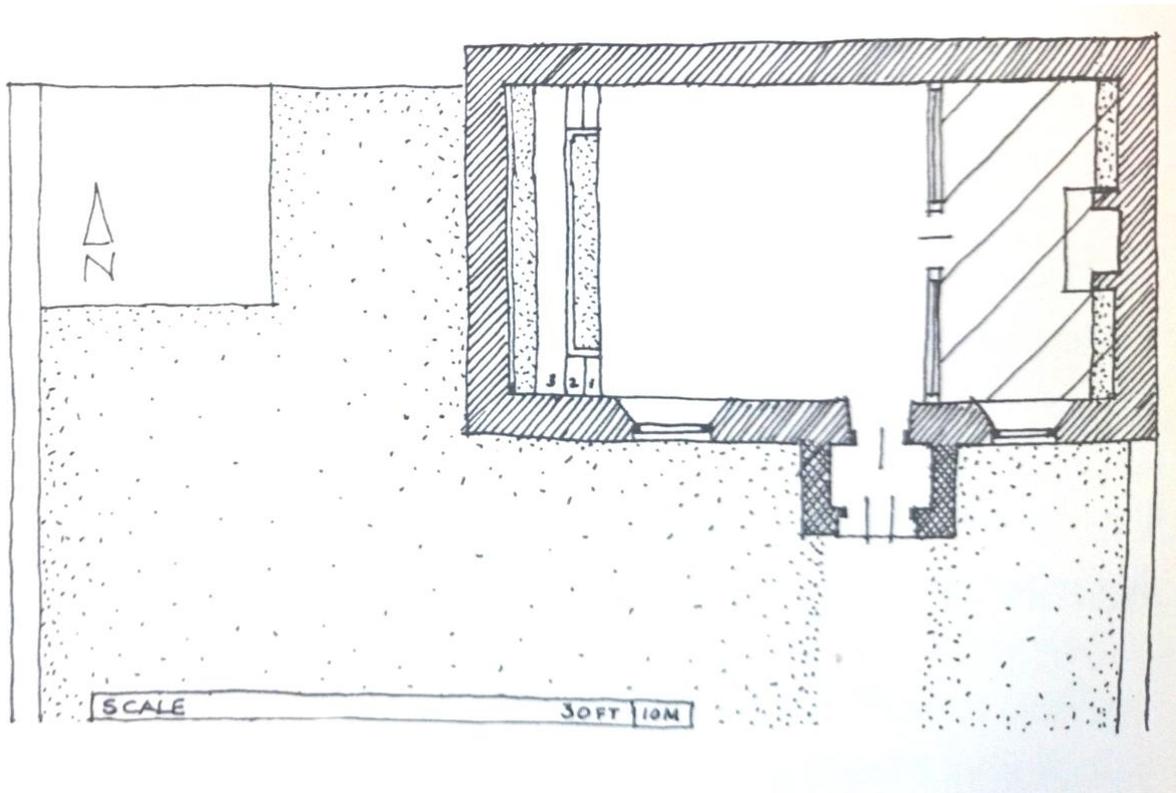
Figure 2: Ground floor plan of the meeting house as reconstructed by Butler (Butler (1999), vol. 1, p.78)

The 3-bay building is rectangular in plan with a south porch, and is divided internally into two principal spaces: the larger meeting room to the west and the smaller former women's room, now an ancillary area to the east. The south elevation has a gabled porch to right of centre with a stone chamfered lintel above the planked door. To the left and right of the porch are sash windows with glazing bars and to the upper right of the elevation is a 2-light stone mullioned window (formerly lit the loft). The east gable end is built directly onto Front Street, in plain stone with a gable-end stack, whilst the west gable is lime-rendered. A two-storey stone building abuts the north elevation of the meeting house.

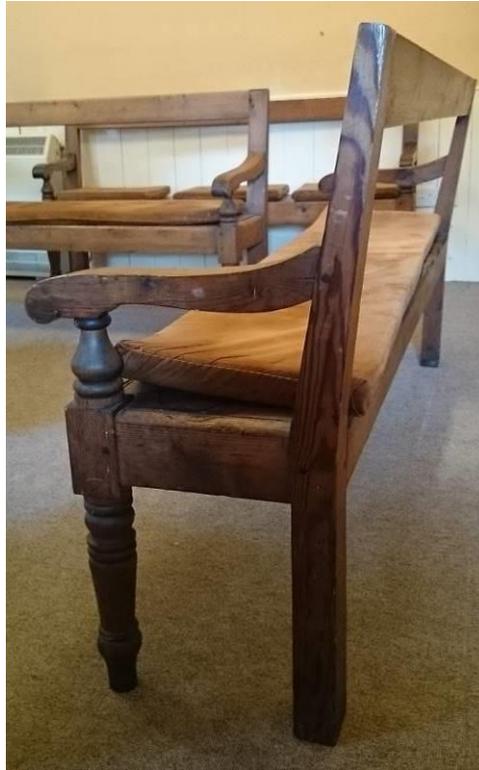
Figure 3: Meeting room benches

No historical information about the benches is available (Fig.3). The turned front legs of the benches match the design of the fixed bench to the minister's stand, which suggests they date from 1859.

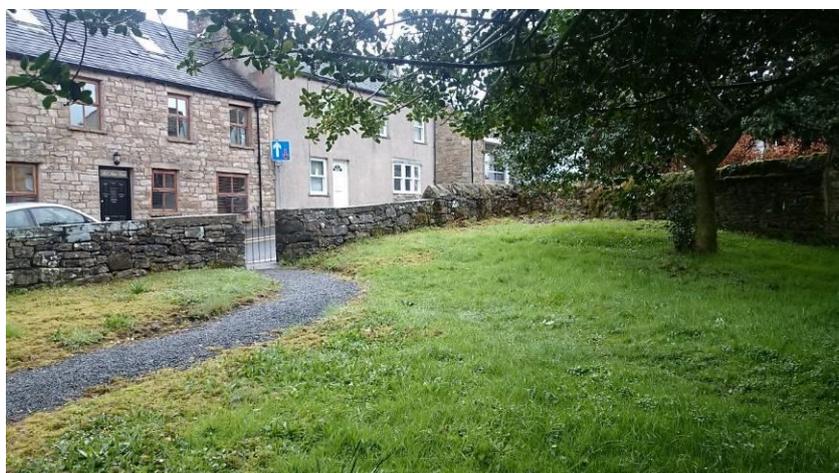
Figure 4: Burial ground (from the north)

The burial ground is located to the south side of the meeting house, enclosed by a dry stone front wall with simple metal gate from the street. The Alston burial ground expresses simplicity and contains no headstones. The Alston Meeting burial registers identify sixteen burials which include a number of early Quakers from the Pickering family. The earliest known burial was of John Pickering in 1805 and the last in 1874.

ii) Attached burial ground (if any): Optimal/satisfactory. The drystone wall is in good condition. The top stones are all in place to the south and west walls. No signs of bowing or bellying and no fallen stones. The burial ground itself is well maintained.
