Friends Meeting House, Bardfield

Brook Street, Great Bardfield, Braintree, Essex, CM7 4RQ

Statement of Significance

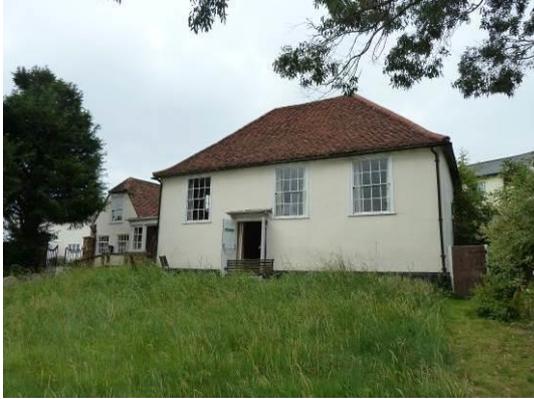
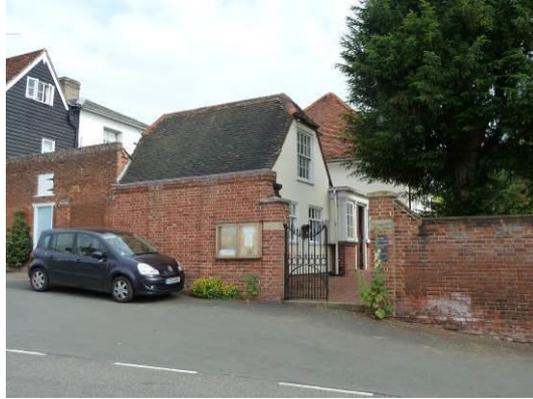
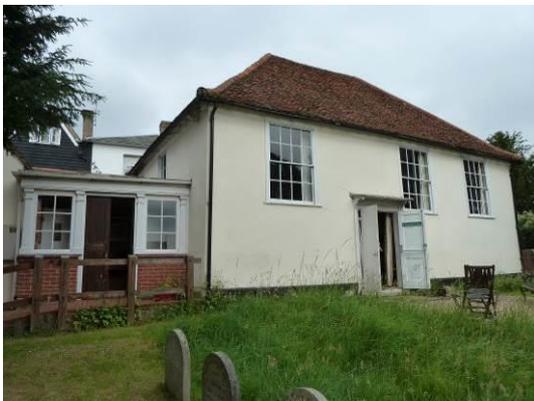
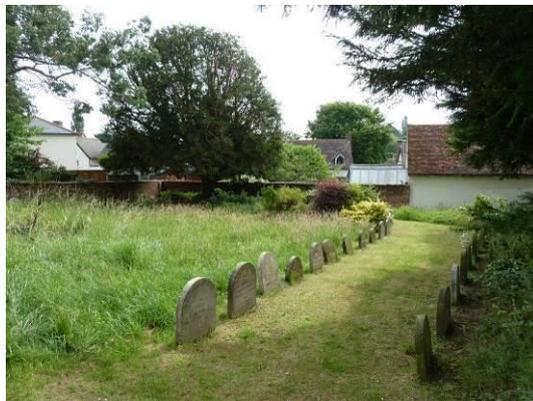
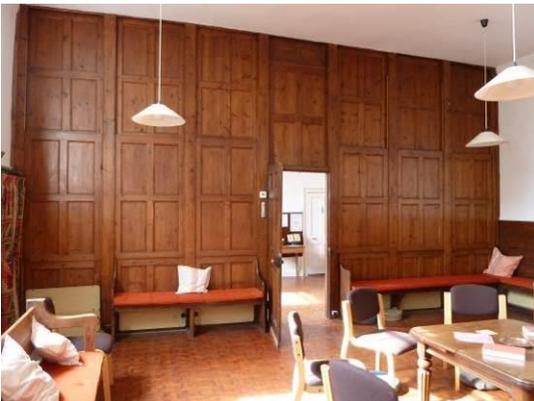
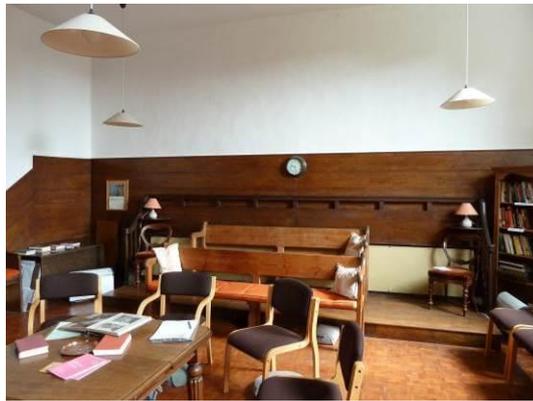
The burial ground lies to the east of the meeting house. It is enclosed by brick walls and contains burials from 1806. The older gravestones are lined up along the north wall. The only standing headstones are two rows near the entrance (photo centre right). The last burial took place in 1953 and the burial ground is no longer used for burials, only for the burial of caskets of ashes and the scattering of ashes. A burial plan of 1930 shows 88 burials (figure 1); there is apparently no up-to-date burial plan. The small shed shown on the 1930 plan no longer exists.

The burial ground was landscaped in 2008 which created a slightly elevated gravelled platform for outdoor seating just outside the meeting house (photo centre left). Most of the burial ground is maintained as a wildlife garden and only one path is mown around its circumference. There are several conifers just inside the boundary wall to the street.

The meeting house is slightly set back from Brook Street. The entrance to the site is through gates between brick piers and a brick-paved path to the meeting house. Due to the narrow entrance there are only oblique views of the meeting house from the street (photo top right). The meeting house, its sympathetic extensions, the boundary wall and the trees all make a positive contribution to the conservation area. Brook Street, Vine Street and Crown Street form a triangle at the heart of the village.

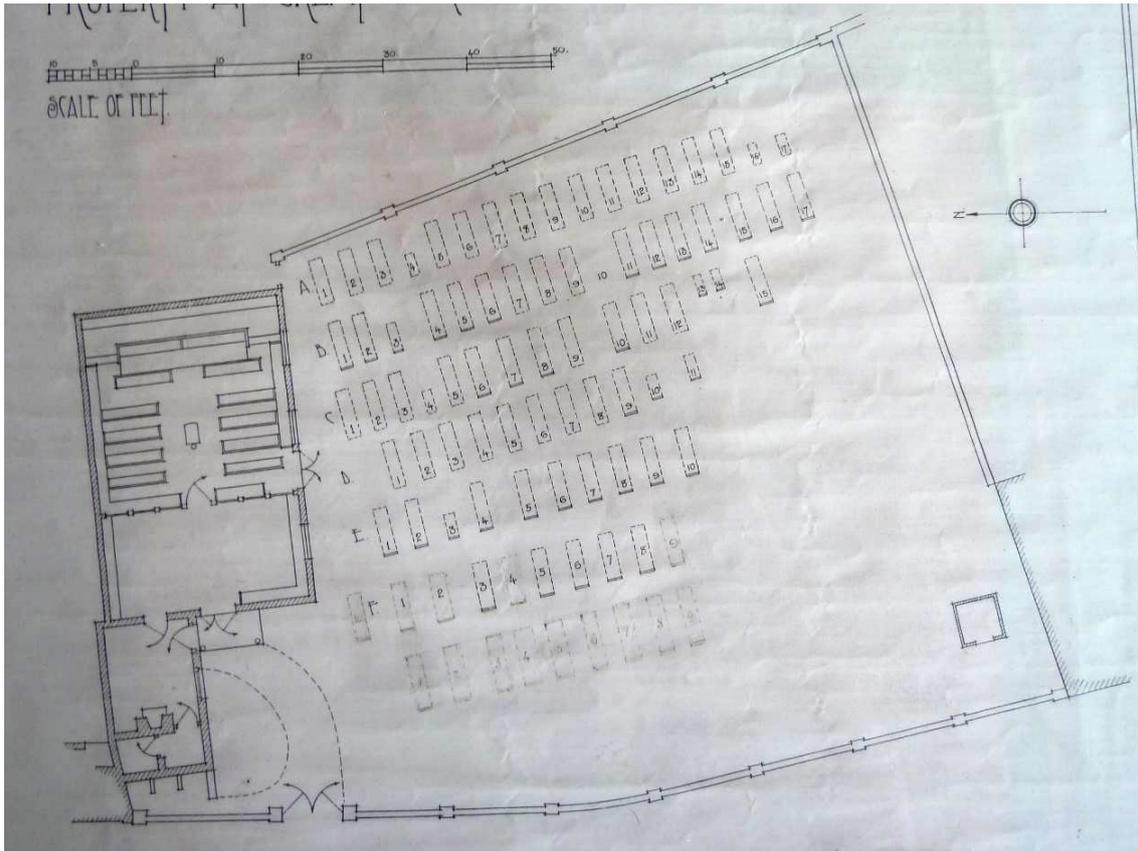
Figure 1: Plan of the meeting house and burial ground in 1930 by D.G. Armstrong, architect and surveyor. (North is actually at the top of the image; not to scale)
(Great Bardfield Meeting House archive)

As the meeting house was constructed in the former garden of Buck's House, there remains a right of way for the residents through the burial ground to the street. The gate is at the northwest corner of the burial ground (figure 1).

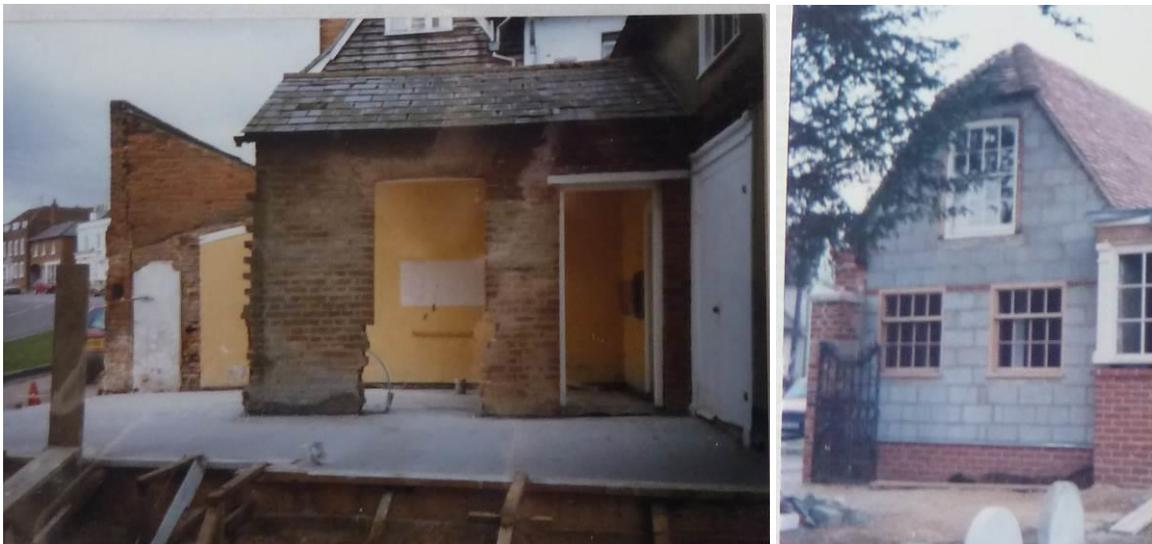
Figure 2: The demolition of the 1848 extension (left) in 1985 and the newly constructed extension before rendering (right) in 1986 (Great Bardfield Meeting House archive)

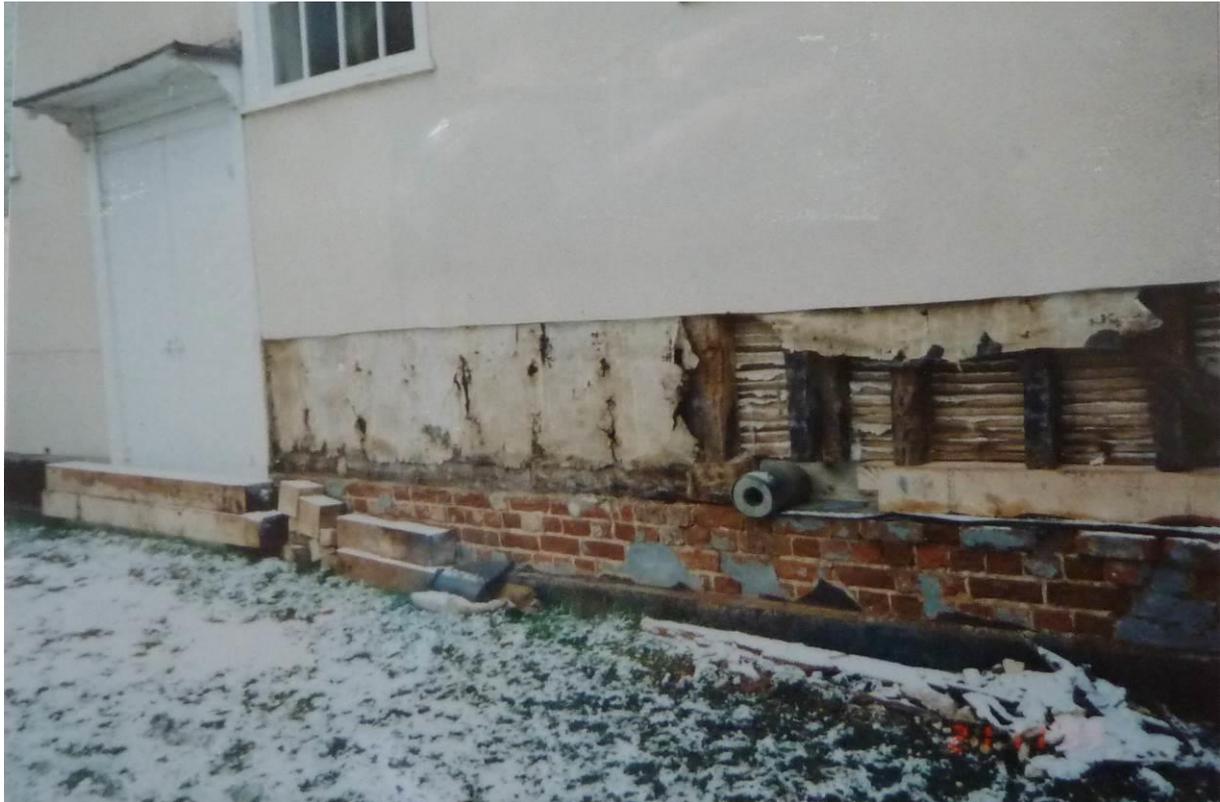
Figure 3: Repairs to the sole-piece in November 1993, showing the timber framing (Great Bardfield Meeting House archive)
