Friends Meeting House, Bentham

Calf Cop, Burton Road, Low Bentham, LA2 7ET

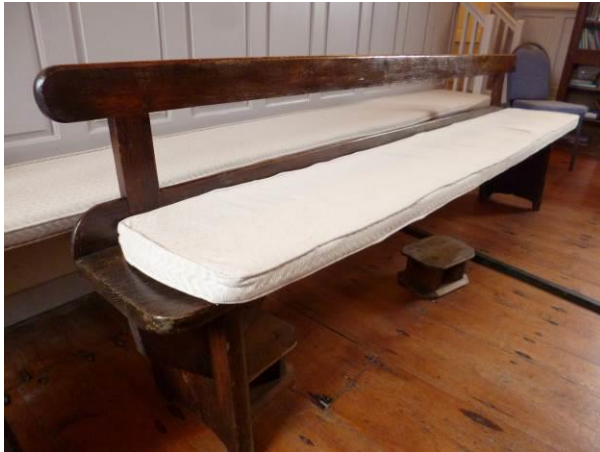
Fig.4: open-backed pine bench

The meeting house contains six open-backed pine benches of similar design and also two benches with solid bench ends (similar to those in Airton meeting house). The gate-leg table in the centre of the meeting room has legs of early eighteenth century date but the top is Victorian. There are also two eighteenth century oak chairs, with pierced splat backs, in the hall.

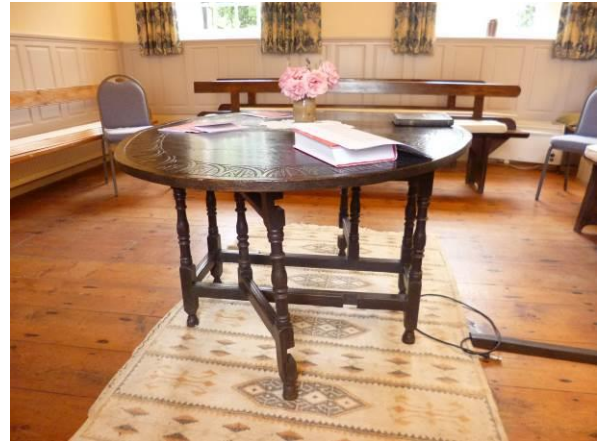
Fig.5: gate-leg table in meeting room

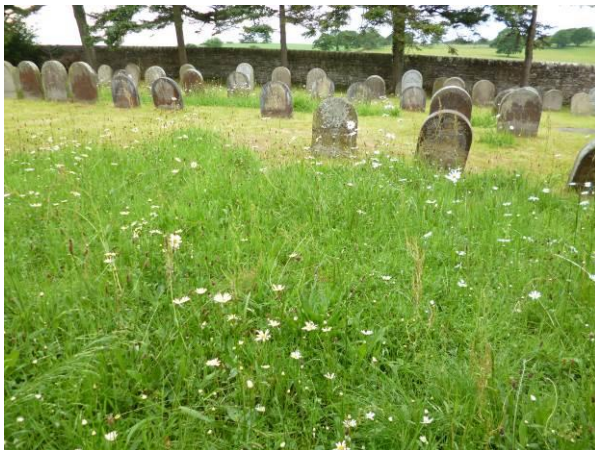
Fig.6: the burial ground from the east

The meeting house stands towards the north side of a large square burial ground, enclosed by well-built mortared stone walls with half-round copings. The walls are about 2 metres high, with tooled quoins forming gate piers to the main east entrance, aligned with the porch of the meeting house. The walls are separately listed Grade II. There is also a small (recent) gateway on the south wall giving access to the adjoining allotment gardens. The former outside men's toilets in the north-east corner were in a dilapidated state, but have been renovated to provide a tool shed for use by allotments holders. The burial ground is laid to grass with areas allowed to seed to encourage wildlife. Perimeter trees include mature yew trees and conifers. The burial ground records run from 1836 to the present day, and are kept at the meeting house. The plain semi-circular headed memorial stones are arranged in rows aligned north-south.

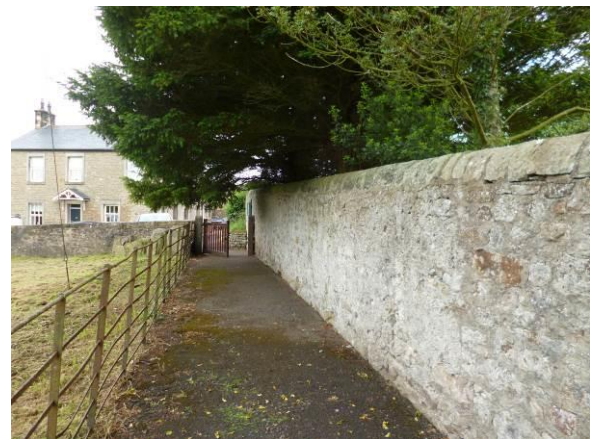
Fig.7: east wall to burial ground, from the north
