Friends Meeting House, Bournemouth

16 Wharncliffe Road, Boscombe, Bournemouth, Dorset, BH5 1AH

Statement of Significance

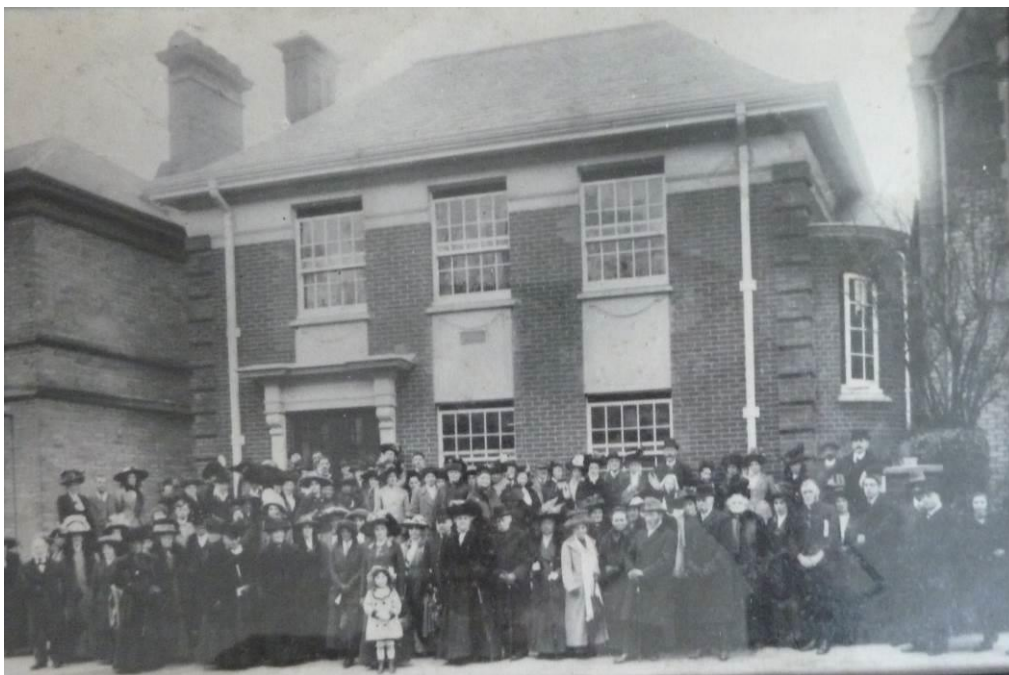
Figure 2: The former meeting house of 1912 (Local Meeting archive)

structural problems due to insufficient foundations prompted a rebuilding on the same site instead (cost: £1,313). This was a building in the Queen Anne/Georgian Revival style with a tall hipped roof (figure 2).

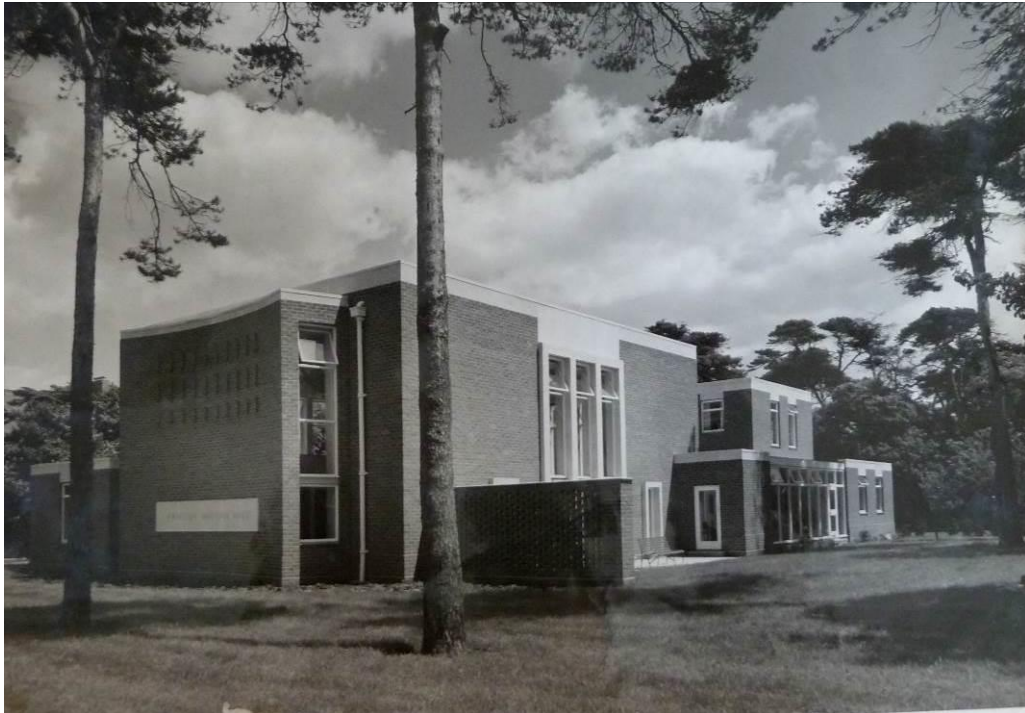
Figure 3: The new meeting house shortly after completion in 1964 (Local Meeting archive)

In 1964, the meeting house in Avenue Road was acquired by Marks & Spencer who redeveloped the site in return for paying for a replacement building in Wharncliffe Road, Boscombe. (Apparently, no money changed hands during the transaction.) This, the current meeting house, was built by the architects Dexter & Staniland in 1964 and opened on 20 June that year (figure 3).
