Friends Meeting House, Colthouse

Colthouse, Ambleside, LA22 0JU

Statement of Significance

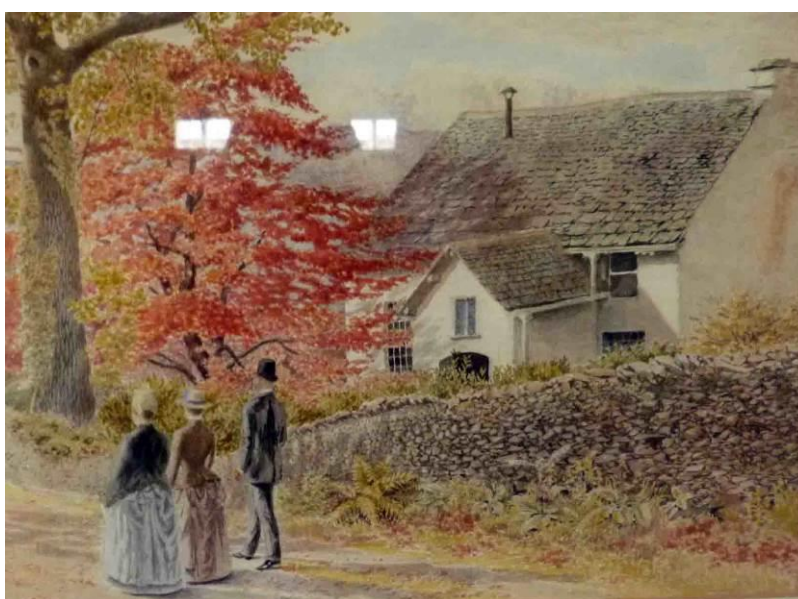
Fig.1: detail from a painting by William Satterthwaite, 1889 (Colthouse Friends collection)

room (the flue pipe can be seen in Fig.1); this room may have been unheated originally. Butler's plan shows a fitted bench inside the door to the large meeting room but this was removed at an unknown date. Quakers did not need to build their own stables, instead leasing stables at nearby Town End Farm. In 1960, the south windows were re-glazed and in small meeting room windows re-glazed in 1967. 1977, an addition was built on the north side for a kitchen and toilets.

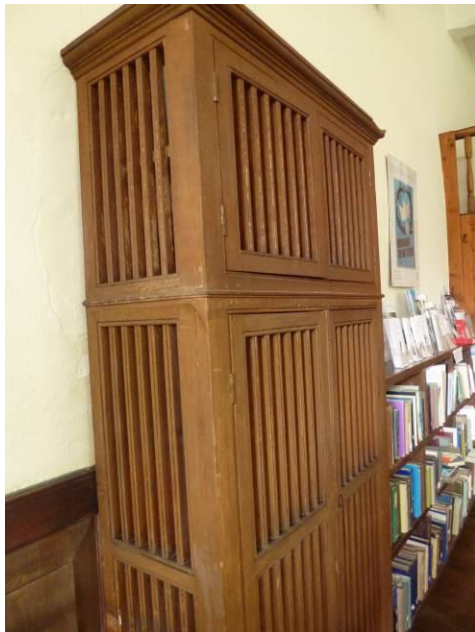
The meeting house contains six loose benches set against the walls, made of pine with railed open backs and shaped arm rests. There is an oak chest of late seventeenth date and against the west wall a document cupboard or book press with open slatted front and sides; the meeting's minutes record that the Friends had a well-stocked library here from early on. There is a pine teachers' desk in the small meeting room. Modern chairs are arranged in a circle in the large meeting room.

Fig.3: document cupboard

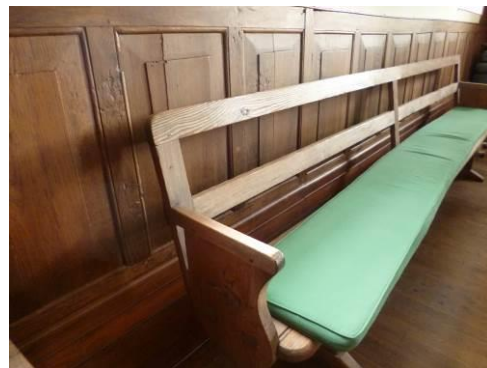
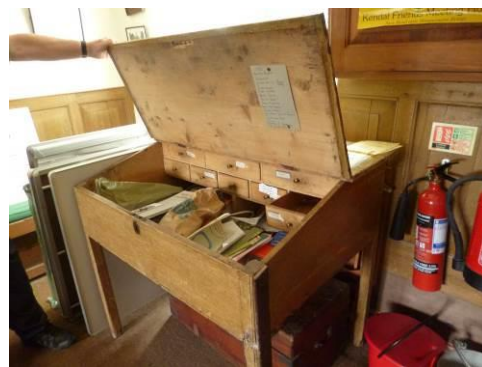
Fig.4: pine bench and teacher's desk

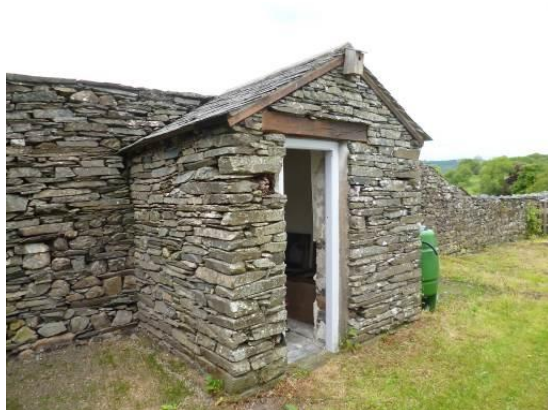
Fig. 5: privy behind the meeting house

The meeting house is rightly listed at Grade II*. The listing could be extended to also include the boundary walls and the privy. The detached burial ground walls are listed Grade II.

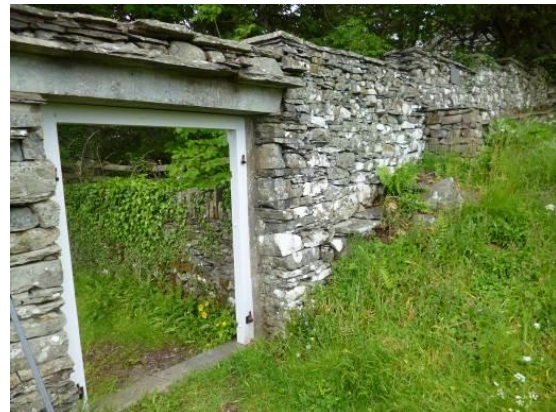
Fig.6: inside the detached burial ground
