Friends Meeting House, Colwyn Bay

21 Erskine Road, Colwyn Bay, LL29 8EU

Statement of Significance

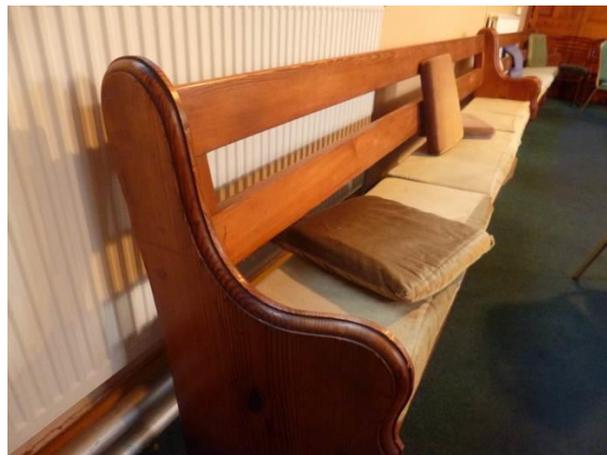
Fig.4: pine benches, probably contemporary with the meeting house

The meeting house contains a set of five pine benches with curved bench ends and plain horizontal rails to the backs; these are now set against the walls of the main meeting room and loose chairs, arranged in a circle, are used for meeting for worship. There are two pine book cases, provenance not known.
