Friends Meeting House, Cotherstone

Cotherstone, Barnard Castle, DL12 9PG

Statement of Significance

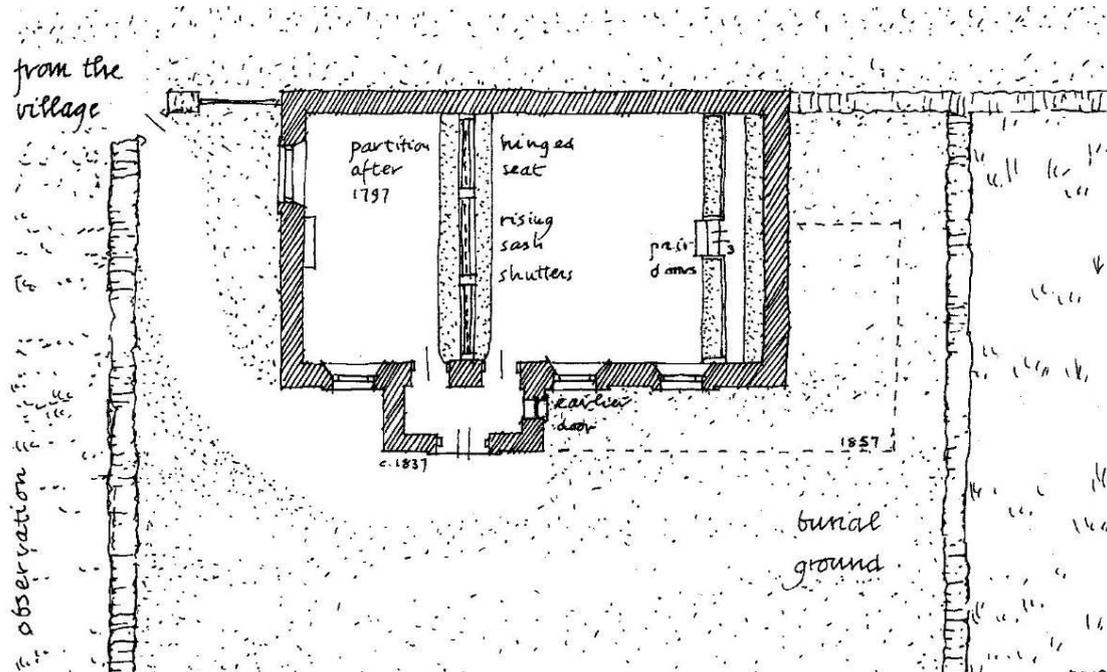
Fig.1 plan of the meeting house in 1987, *Butler 1999 vol.2 p.732*, (north is at the top). The plan shows a window opening in the west wall which is now built-up.

A single-storey cloakroom passage was built along the north and east sides in 1857. In 1987 the building was repaired and refurbished. The cloakroom was removed, a pitched roof was built onto the porch and a window opening in the west wall was built-up.

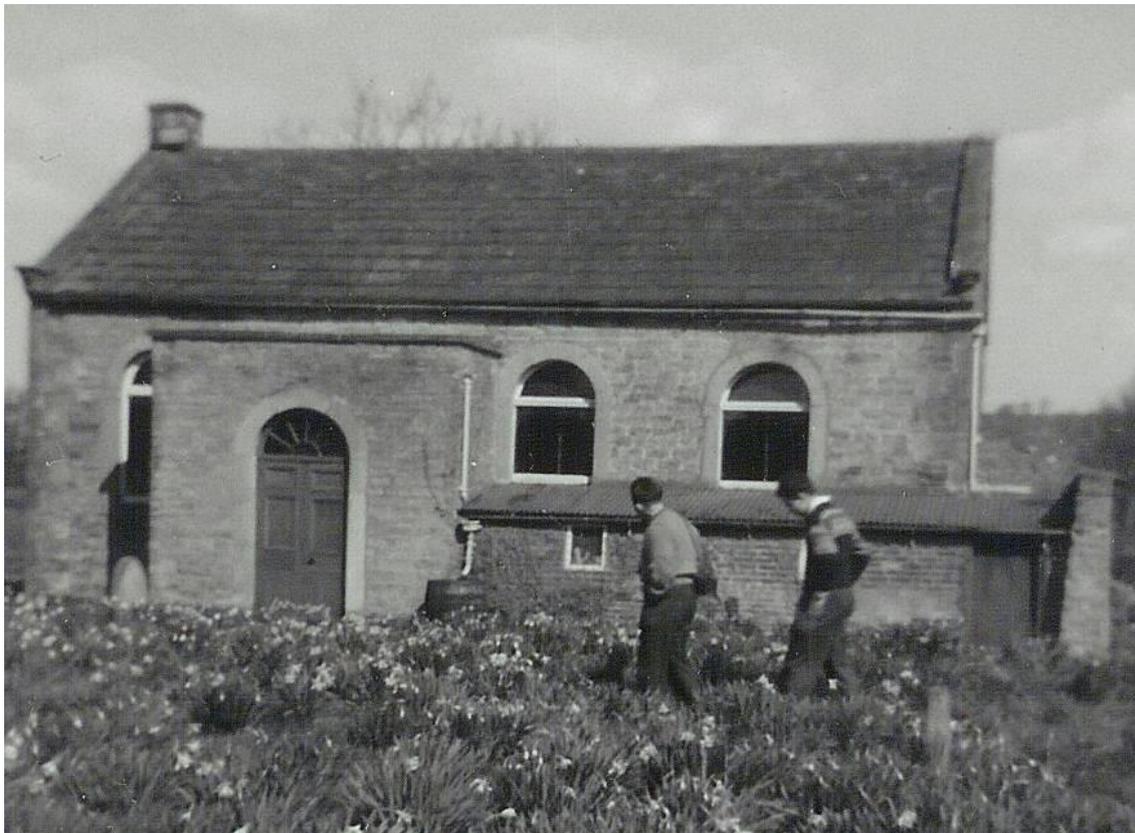
Fig.2 The meeting house before the 1980s refurbishment, showing the modern glazing, the lean-to cloakroom addition and the flat-roofed porch (Local meeting collection).
