Friends Meeting House, Crawshawbooth

13 Co-operation Street, Crawshawbooth, Rossendale, BB4 8AG

Statement of Significance

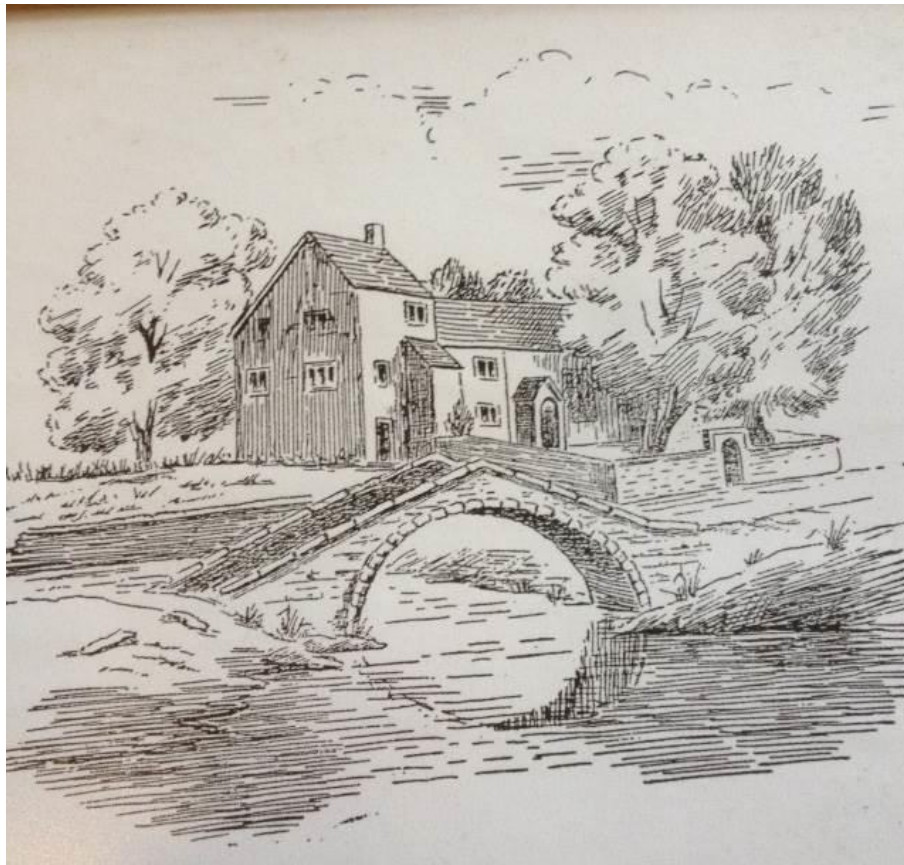
Figure 1. Illustration based on an engraving of 1798 (Crawshawbooth Meeting)

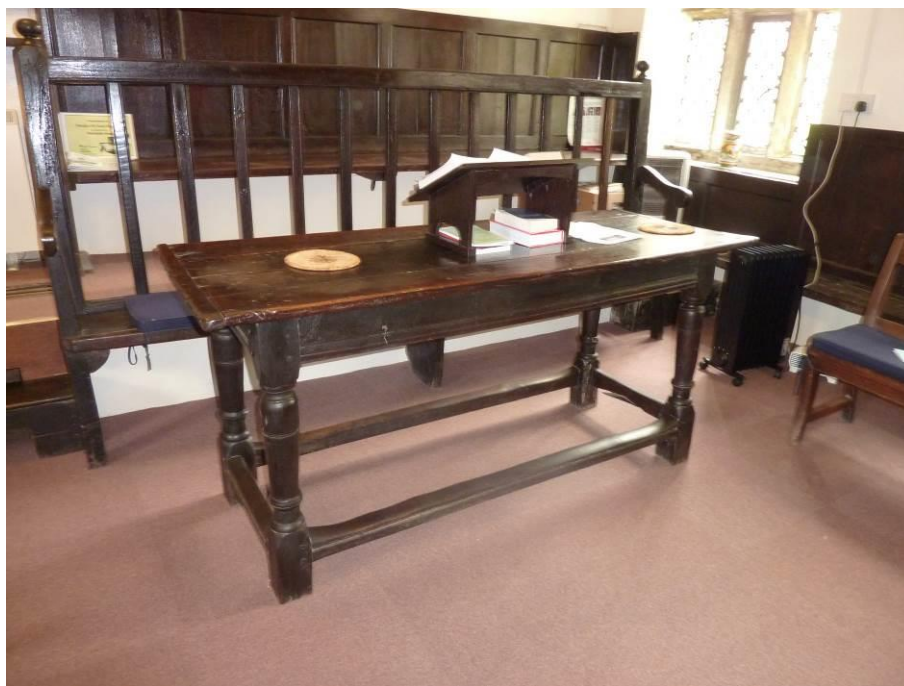
Figure 3. The seventeenth-century table

There is a large free-standing table of simple construction with turned legs which is reputed to be of early seventeenth century date, however it may be somewhat later in date. A sturdy rustic chair of similar date is said to have belonged to or been used by George Fox. These furnishings are of high intrinsic interest and seem to have been associated with the building for a considerable period, possibly since the inception of the meeting house. In addition there are a number of free standing benches of oak which are probably of nineteenth or early twentieth century date, a probably earlier bench in the smaller room, and a number of painted chairs of differing designs and dates, probably including nineteenth century examples. There is also a large cupboard, possibly of early nineteenth century date, in the gallery.

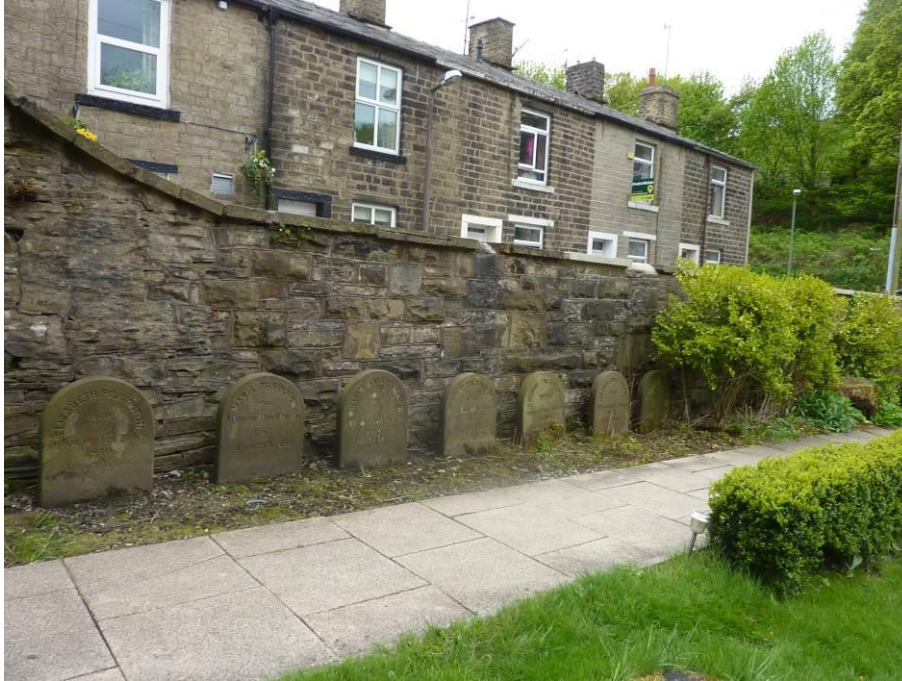
Figure 4. Reset marker stones in the burial ground

The attached burial ground is enclosed by a stone wall with flat copings, probably rebuilt in the twentieth century. A number of headstones have been moved and ranged along the inner sides of the boundary wall. The area was extended in 1823 and in 1875; an indication of the original arrangement is shown in figure 1. A list of interments is held at the Lancashire Record Office, with an approximate date range of 1728 to the 1980s.
