Friends Meeting House, Dunmow

New Street, Great Dunmow, Essex, CM6 1BH

Statement of Significance

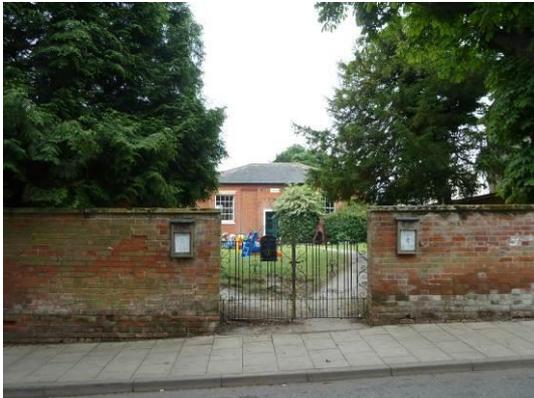
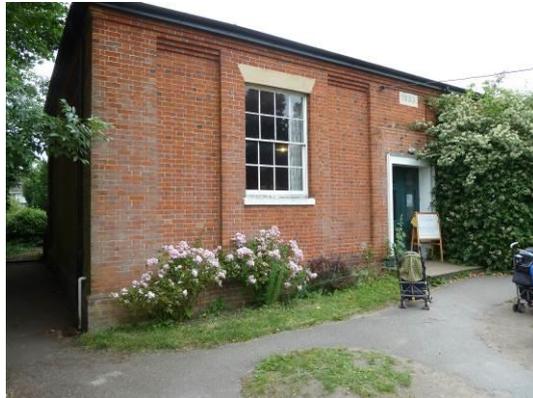
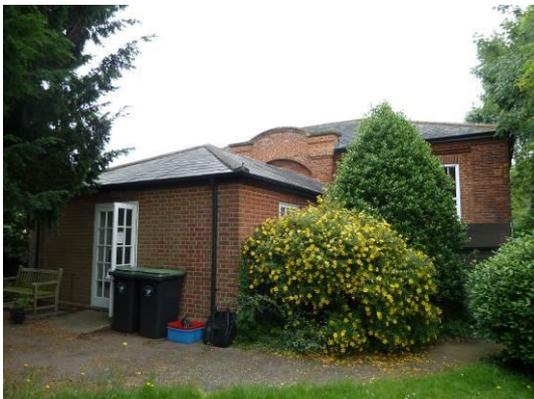
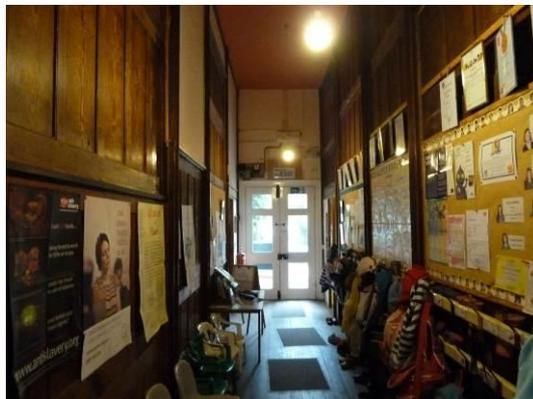
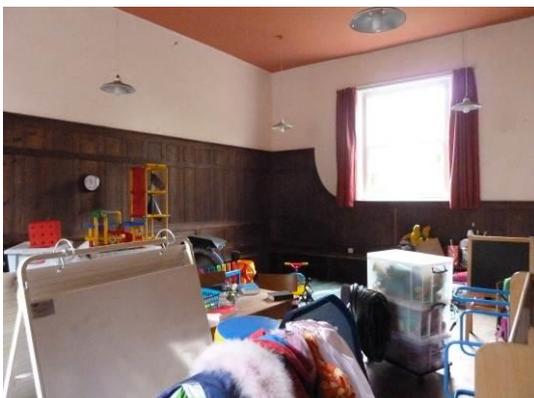
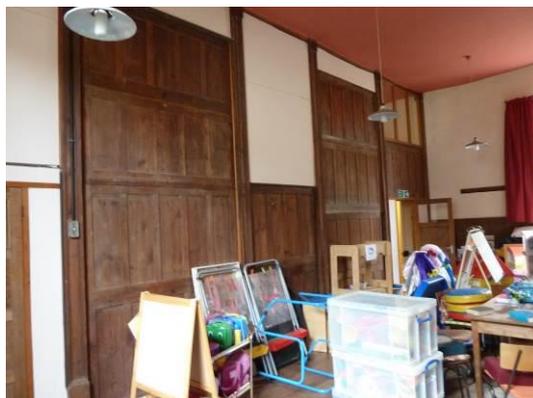
The interior is divided by a corridor of timber-panels into two rooms of equal size (photo centre right). This may have been originally moveable panelling to create one large room. All four doors appear to have been replaced. The room to the north is the current meeting room (photos bottom left and right). It has timber dado panelling which ramps up to the north wall, the former location of the elders' bench. It has fixed benches against the north, east and west walls, and a suspended timber floor. The other room (in nursery use during the visit) is similar. Both rooms have octagonal recesses in the ceiling, probably for light fittings. The modern extension contains toilets, a kitchen and a store room.

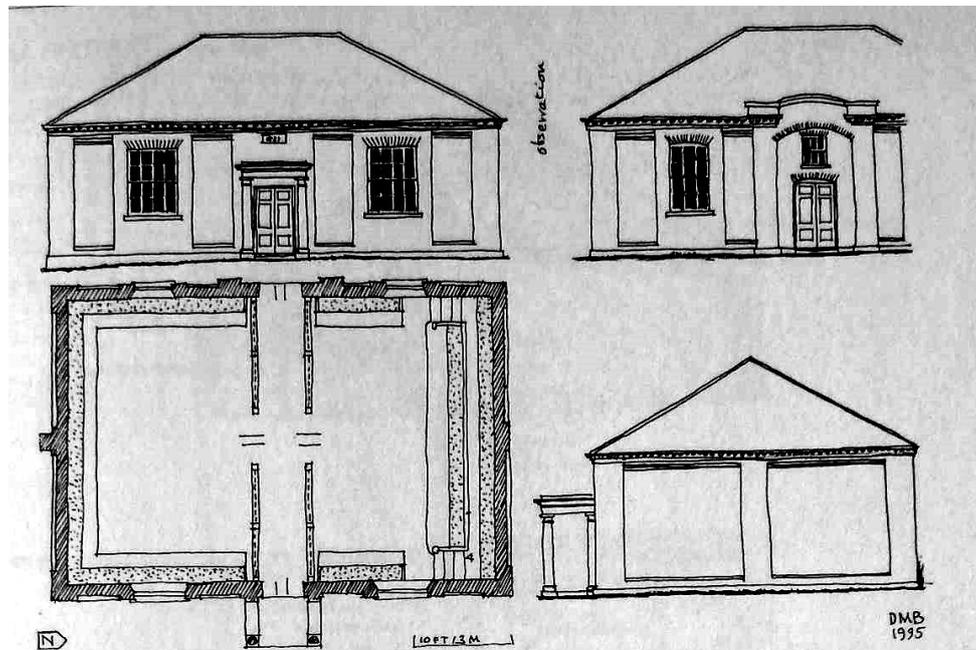
Figure 1: Plan and elevations (north is to the right of the plan; not to scale)
(Butler (1999), vol. 1, pp. 185)

At some point during the mid-twentieth century, the meeting was in abeyance, when the building was in full-time use as a nursery (from c.1966). The meeting house was reopened for weekly meetings in 1978. In 1975, when Butler visited, the entrance had a columned porch (figure 1) – this had been removed by 1989 (when a survey was undertaken). Also removed were the elders' bench and dais shown in Butler's drawing (figure 1). In 1993, the architect Simon Ward RIBA built a small single-storey rear extension providing toilets, a store and kitchens. The cost of the extension was about £34,000. In 2007, repairs were made to the roof where the extension adjoins the building.

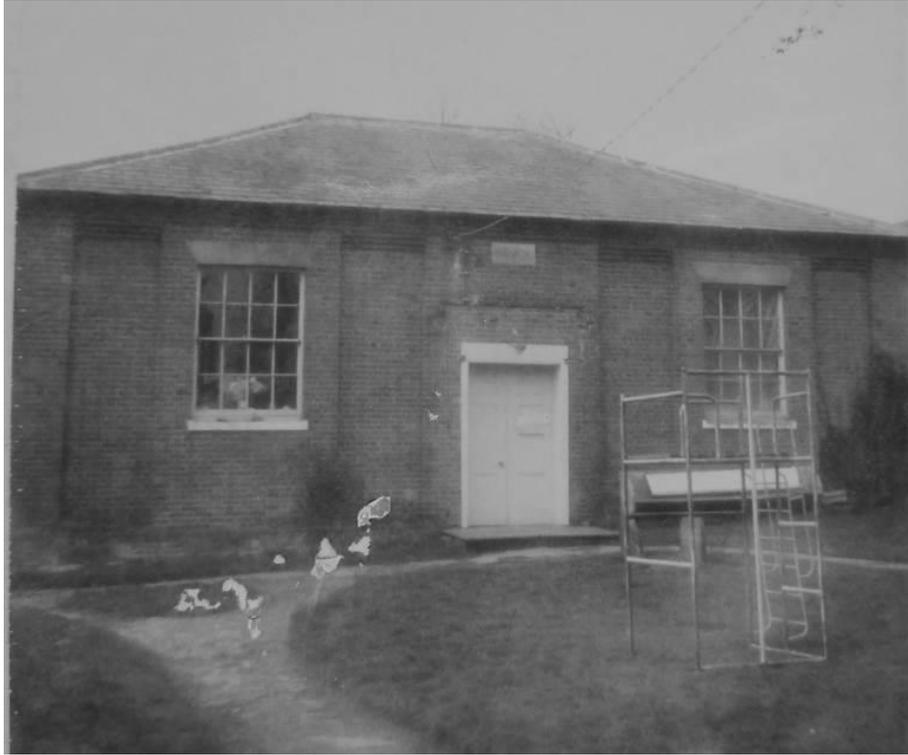
Figure 2: Undated (post-1975) photo of the front (east) elevation
(Great Dunmow Meeting House archive)

The meeting house was built in 1833 (according to a date stone on the east elevation) and extended in 1993. It is a red brick building (in Flemish bond) with stone dressings and a hipped slate roof. The plan is oblong, with the wider sides to the east and west. The east elevation has a central entrance with the date stone above, flanked by two sixteen-pane sash windows. On either side of the windows are recessed brick panels. This motif is repeated on the south and north elevations which have two larger panels and no windows. The west (garden) elevation was originally similar to the front elevation in its rhythm of recessed panels (the outer southwest one has an inserted window), sash windows (here only twelve-pane) and a central entrance bay. The latter was originally surmounted by a small window and the whole encompassed by simple brick pilasters supporting an arch and a segmental pediment above. Only the top of the pilasters and the pediment are now visible above the 1993 extension (a plain brick structure with a hipped roof).

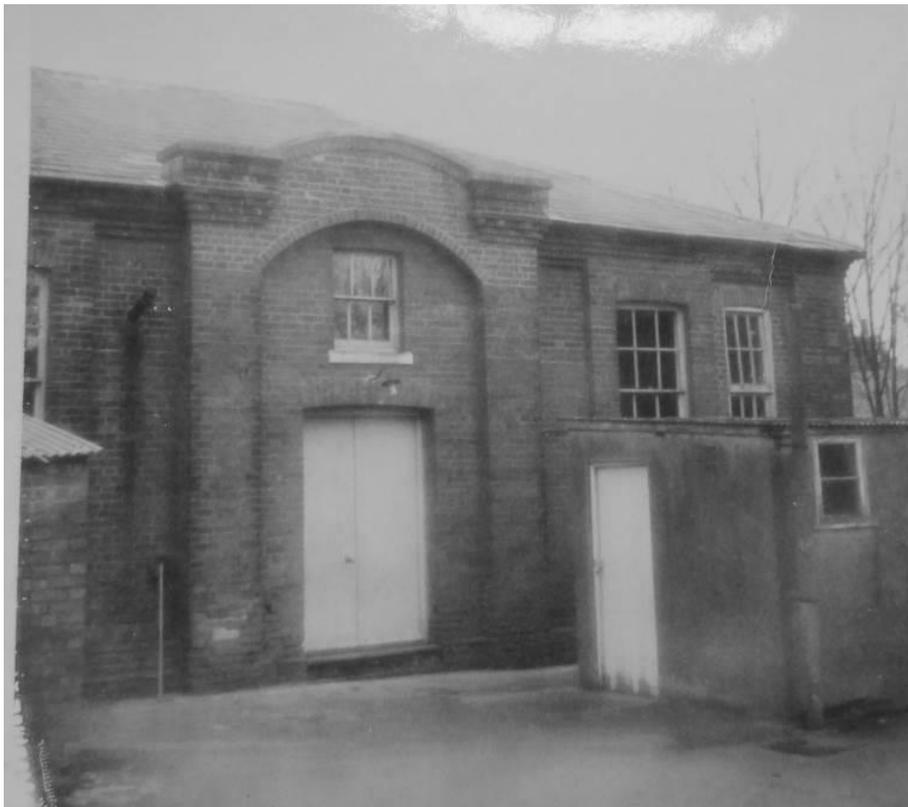
Figure 3: Undated photo of the rear (west) elevation before the 1993 extension
(Great Dunmow Meeting House archive)
