Friends Meeting House, Garstang

Calder House Lane, Garstang, PR3 1ZE

Statement of Significance

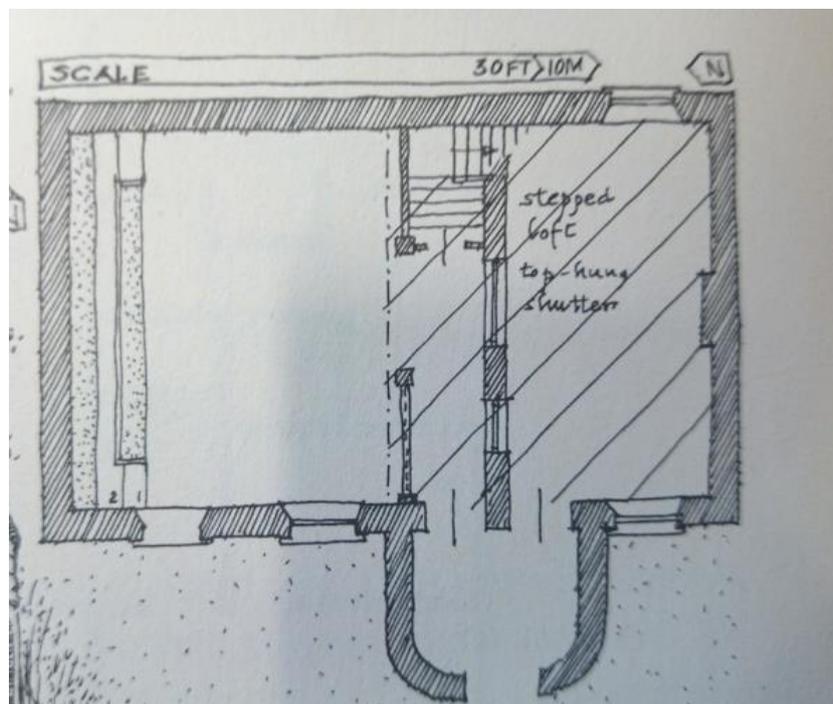
Figure 1. Ground floor plan of the meeting house as reconstructed by Butler (north at the top; not to scale) (Butler (1999), vol. 1, p.296)

The plan conforms to a local type for meeting houses which has resonances with domestic vernacular plan-forms. One inner door gives access to the former women's room and the other to a passageway leading beneath a gallery with steps at the far end (Fig.1). A panelled screen separates the passageway from the main meeting room. This appears to have been opened out at some point at lower level, probably with the removal of shutters. The screen continues up to form the front to the gallery, and there are pilasters accenting the centre and the entrance from the passage. The main (western) meeting room has a panelled dado which is ramped up at the west end to the elders' stand. This has fixed seating against the wall and a fixed bench with a panelled back in front, the top has a balustrade with moulded rail and widely spaced balusters. The panelling and fixed furnishings have a grained finish. There are steps up to the stand at each end, and a shaped divider at the centre of the fixed seating.

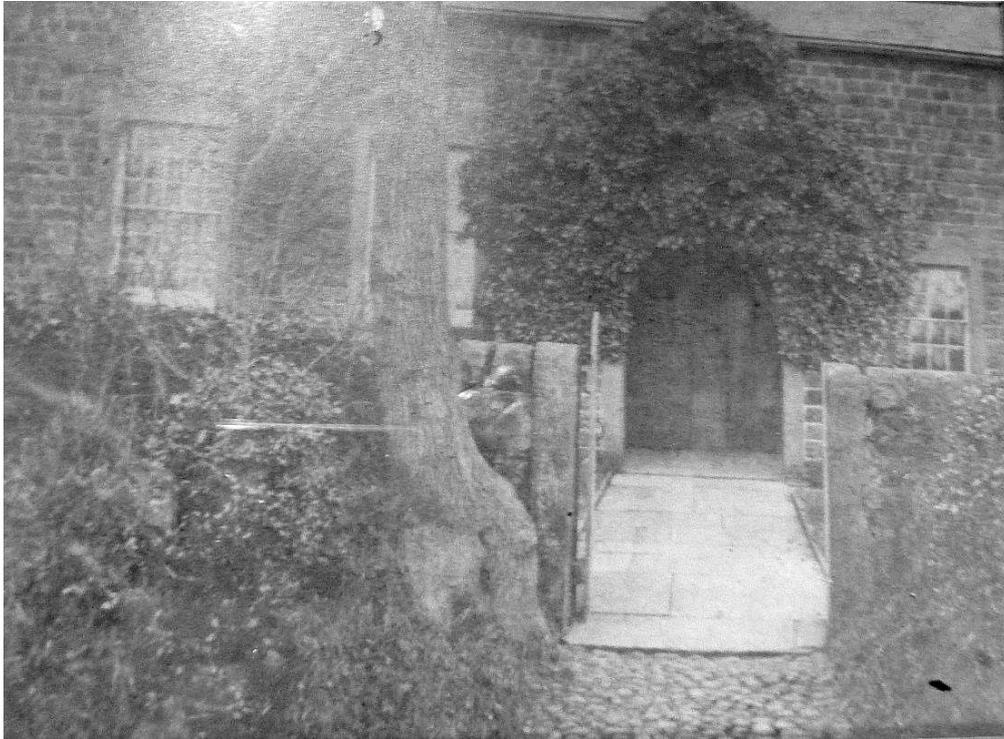
Figure 2. Undated photograph showing the building with multi-paned sash windows before the burial ground was extended (Garstang Meeting).

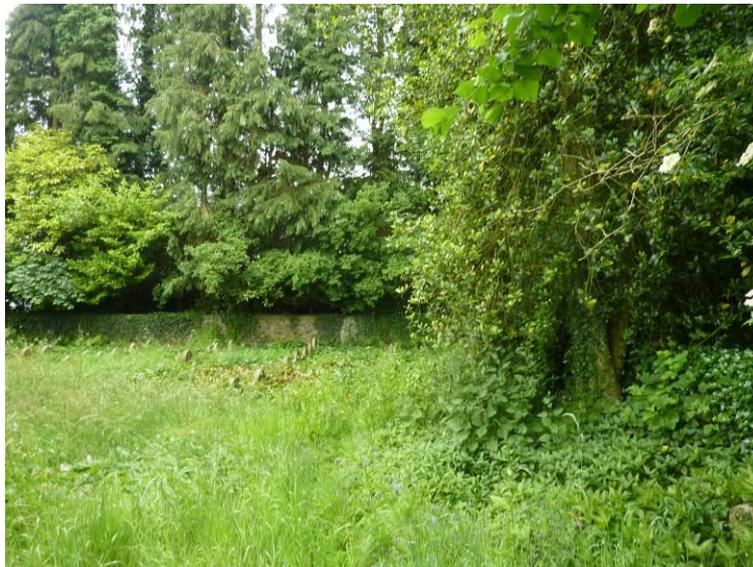
A burial ground on the north and west sides of the meeting house is walled. Headstones of simple form remain *in situ* and the area is managed as a wildlife garden. The burial ground was extended at unknown exact date, probably in the late nineteenth or early twentieth century. Burial records are kept on site and record interments between 1830 and 2015.

Figure 3. The burial ground
