## ***Quaker Meeting House, Great Yarmouth***

*Howard Street South, Great Yarmouth, Norfolk NR30 1LN*

### ***Statement of Significance***

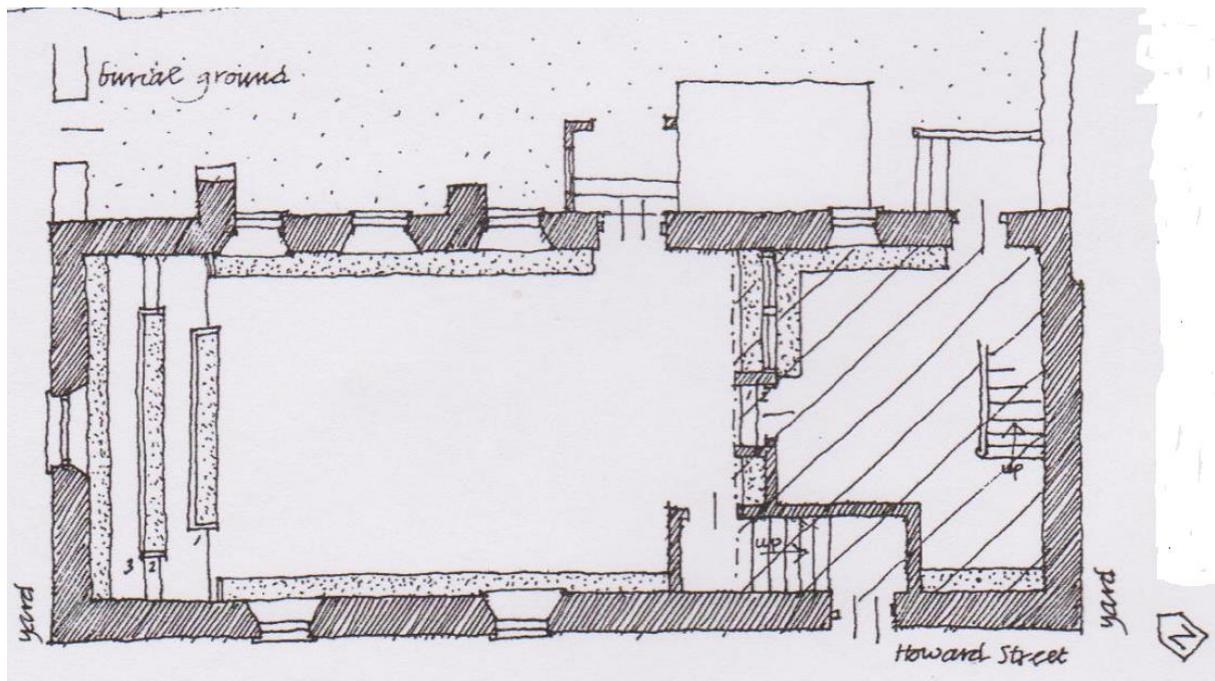
Fig. 1 Ground Floor Plan of the meeting house in 1958 (Butler (1999) vol.1, p462)

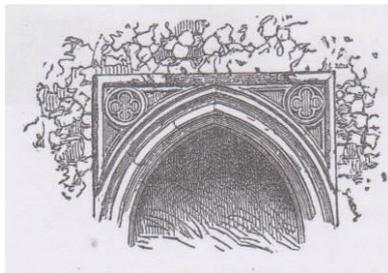
Fig.2 A mediaeval doorway on the Howard Street front, now no longer visible (from Palmer, *The Perustration of Great Yarmouth* (1872) p.323-324)

The building is rectangular on plan, with rendered walls and a pitched pantiled roof. It is possible that the main fabric of the external walls is substantially fourteenth-century in date and it seems likely that the main walls are principally constructed of stone and flint, rather than brick as stated in the current list description. The building was adapted for use as a meeting house in 1694 and completely re-fitted in 1807. The west side towards the street has a modern stone reinforced plinth, a modern six panelled door with a plain fanlight and two 6/6 timber sash windows at higher level which light the meeting room. The North return elevation has a small square opening at low level and a single 6/6 sash window at high level. The South return is similar but with a modern 3/3 horned sash. On the extreme right hand side of this wall is half of a rebated stone arch probably of C15 origin surviving from the earlier building. This arch is not the same as that illustrated by C J Palmer (see fig.2 above) which was apparently on the Howard Street front.
