## ***Quaker Meeting House, Guernsey***

*North Clifton, St Peter Port, Guernsey, GY1 1JR*

### ***Statement of Significance***

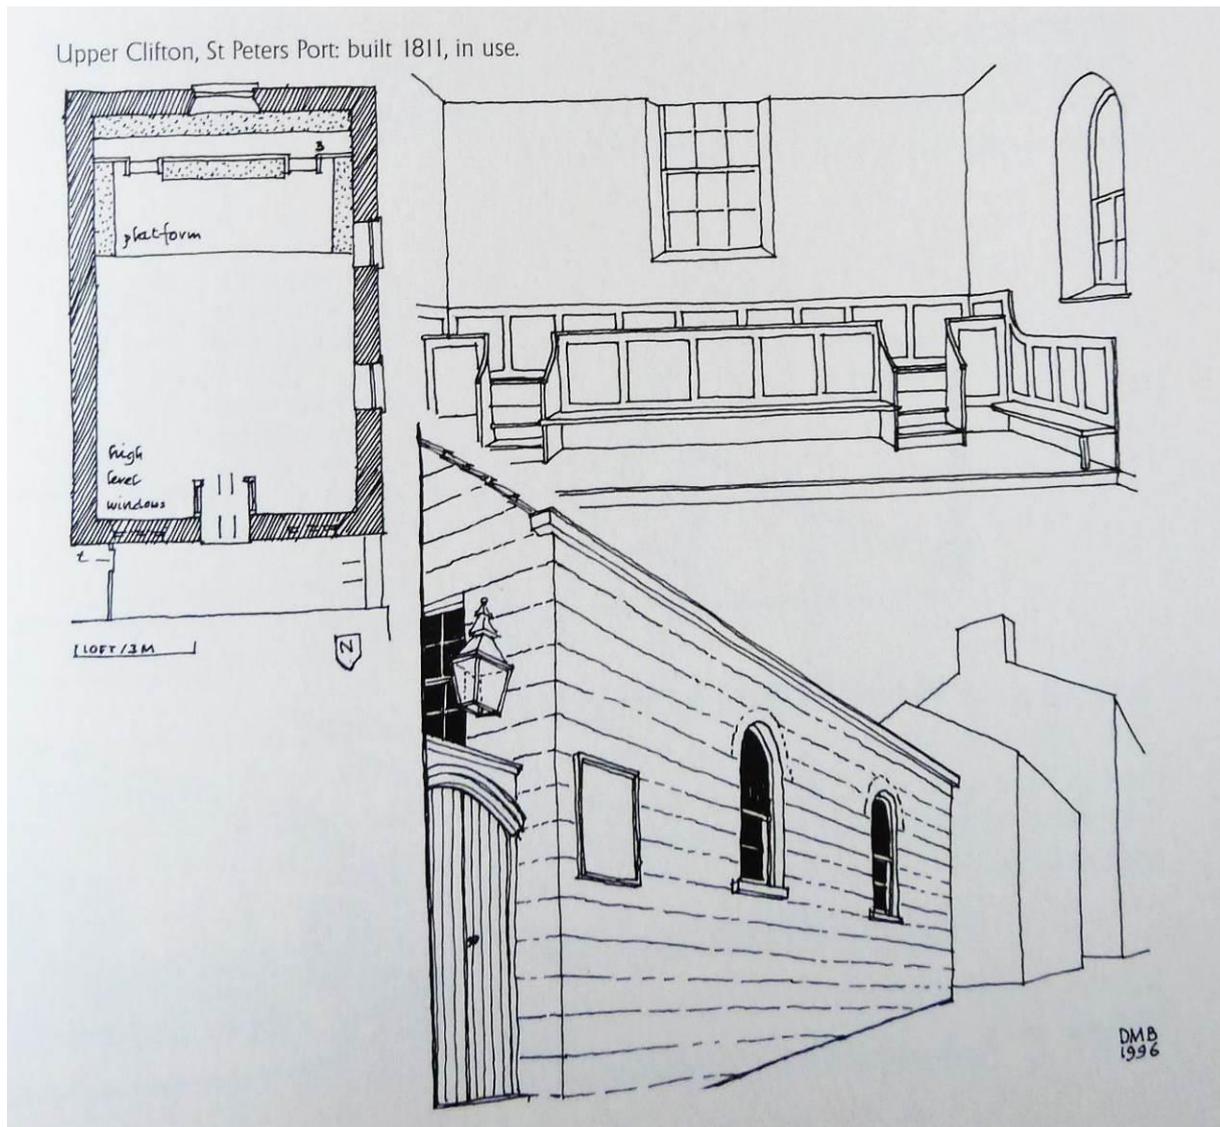
Fig. 1 Plan, internal view and external perspective of the meeting house in Guernsey. (North is at the bottom of the plan; not to scale.) (Butler, vol. 1, p. 233)

The only furnishings of note are the remaining benches and panelling of the ministers' stand. These comprise two rows of timber benches painted white with steps near the end. (This is a type of stand which Butler found particularly common in Yorkshire and London.) Some of the panels were replaced in 1998-99. The lateral benches to the sides shown in Figure 1 have been removed.
