Quaker Meeting House, Llandrindod & Pales

Temple Street, Llandrindod Wells, LD1 5HF

Statement of Significance

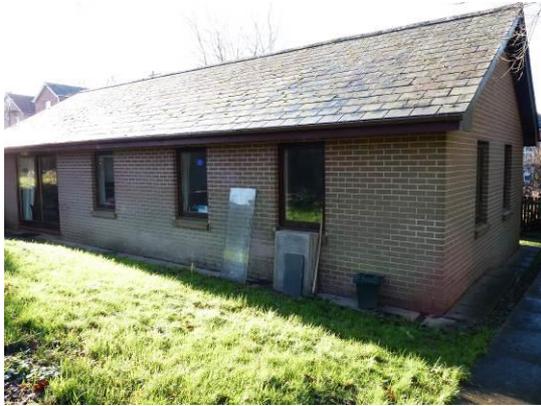
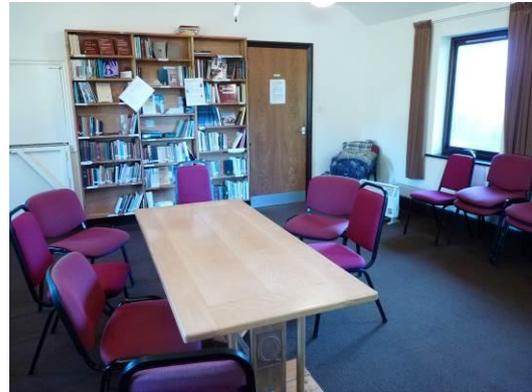
The meeting house built in 1985 is constructed of cavity wall red brick, with a Welsh slate roof with boxed eaves and plastic rainwater goods. Doors and windows are timber. The compact single-storey building is aligned roughly north-south with the entrance in a gabled porch on the long side facing west. The east side has patio sliding doors to the children's room.

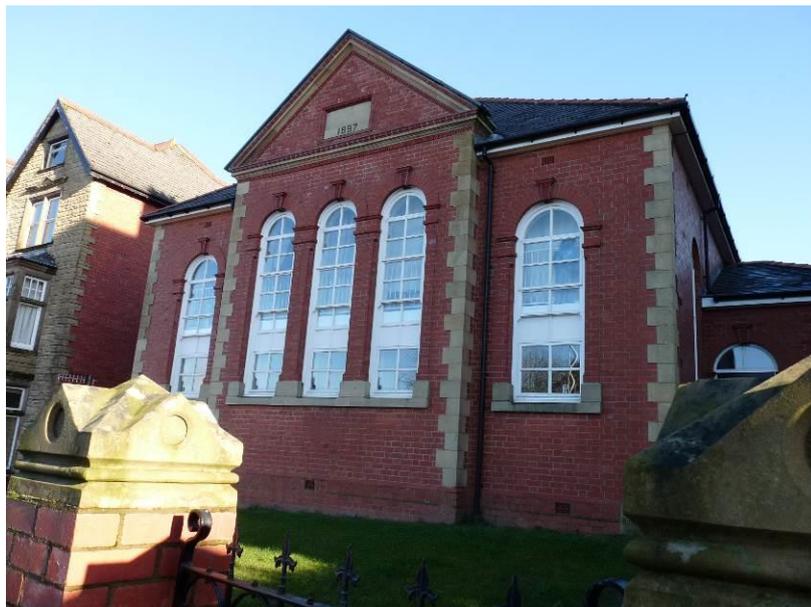
Fig.1: the former meeting house built in 1898
