Quaker Meeting House, Maidstone

170 Union Street, Maidstone, Kent, ME14 1EE

Statement of Significance

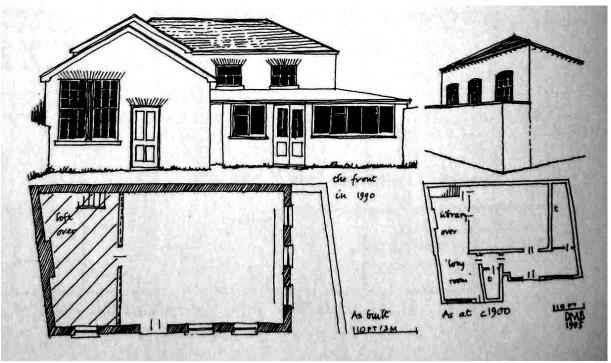
Figure 1: Plan and elevations of 1812 meeting house as in c.1900 (demolished in 1970), from Butler, vol. 1, p. 284

Quaker activity in Maidstone is reported as early as the 1660s, although premises were not acquired until 1807, when a Preparative Meting was established and a room in a property owned by Edward Briggs registered for meetings. Evidently this proved unsatisfactory, not least to Briggs, and in 1811 land for a purpose-built meeting house (and burial ground) was purchased on the west side of Wheeler Street. Designed (according to Butler) by Edward Briggs himself, this consisted of a large meeting room and a smaller one with gallery over, the two areas separated by a partition wall with vertical sliding shutters, in the common manner for late Georgian meeting houses (the shutters were altered and partially removed in 1965). A ministers' stand was placed below high-level windows in the north wall (plan at figure 1).

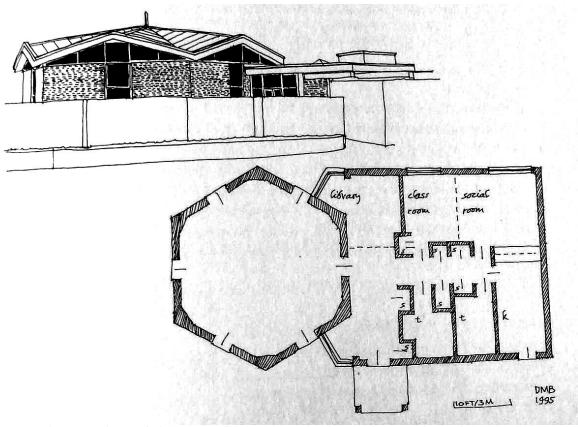
Figure 2: Plan and elevations of present meeting house, from Butler, vol. 1, p. 285

The meeting house consists of two elements, a hexagonal main meeting room capable of seating 100, and the ancillary accommodation (library, small meeting rooms/classrooms, kitchen, WCs) adjoining in a lower building of roughly rectangular plan. Both elements are faced in the same pale concrete bricks, with a folded copper-covered roof to the meeting room and a flat roof covered in felt to the ancillary accommodation. Windows and doors are metal framed. The roof of the meeting room has oversailing eaves, and is lit by tall vertical windows/doors on each of the six faces, supplemented by high-level lighting in the triangular gables. Downpipes are tucked into two of the re-entrants. A deep projecting flat-roofed porch supported on two brick piers marks the main entrance. The accommodation alongside is mainly lit by high-level glazed strips on the street side, and by larger windows and doors on the garden side. Inside, the ancillary spaces are utilitarian in character, though well-detailed and fit for purpose. In the entrance lobby and the large meeting room the walls are of fair-faced brick. The meeting room is an attractive hexagonal space, well-lit on all sides, with the timber roof joists stiffened by steel ties which repeat the form of the hexagon. Seating is arranged in a circular pattern around a central table.
