Friends Meeting House, North Walsham

Quakers Hill, Mundesley Road, Swafield, North Walsham, NR28 0RF

Statement of Significance

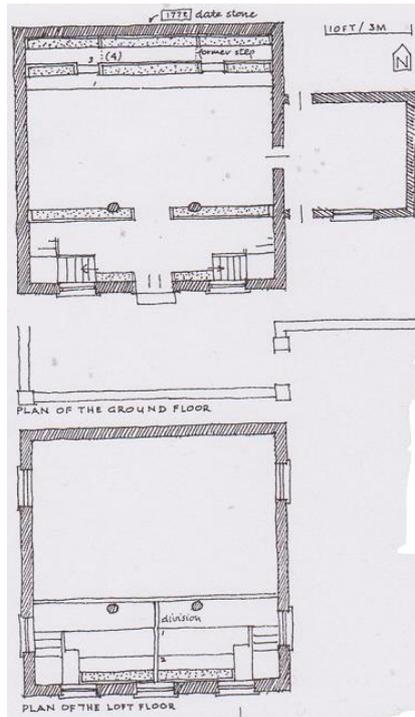
Figure 1 Ground floor and gallery plan (Butler (1999), vol.1, p.447)

According to Butler, the first meeting house was built in 1702 on land given by James Millar. It was replaced on the same site by the present building which was erected in 1772 (datestone on rear elevation) at the expense of William Seker, owner of the nearby watermill. Another account places the earlier building adjacent to the nearby burial ground. The meeting house was carefully repaired and restored in 1984. The roof originally had a central louvre.

The interior has a low full-width lobby containing two flights of stairs rising to a gallery, which is supported on two timber Doric columns, with another pair rising from gallery level to the flat plaster ceiling. The ceiling has a moulded cornice all round. The gallery has a flat-boarded front. The main meeting space in front of the gallery has a vertical boarded dado with fixed bench seating on the line of the gallery columns. On the long side opposite, the minister's stand extends the full length of the room with two raised seats. The dais has been

renewed and simplified. The gallery is divided by a centre partition, which is an unusual feature in so small a building.
