## ***Friends Meeting House, Northampton***

*Wellington Street, Northampton, NN1 3AS*

### ***Statement of Significance***

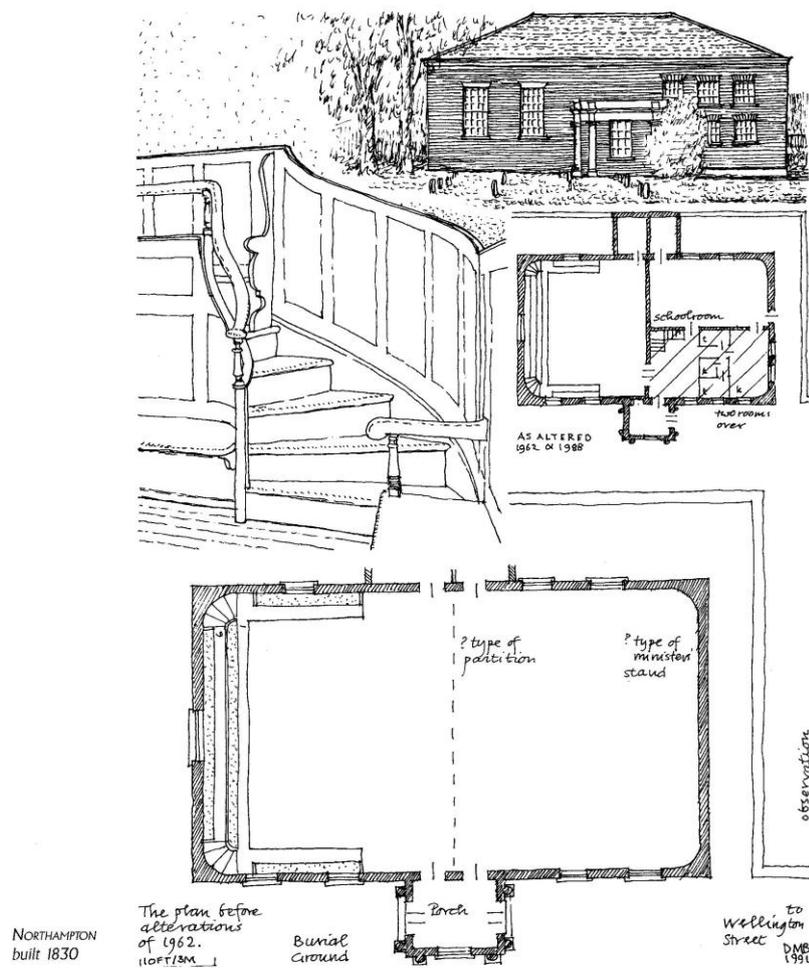
Figure 1: The likely original plan (bottom) with the plan as altered in 1966, a view of the north front and a detail of the stand. North is to the bottom of both plans. *Butler*, Vol. 1, p. 470

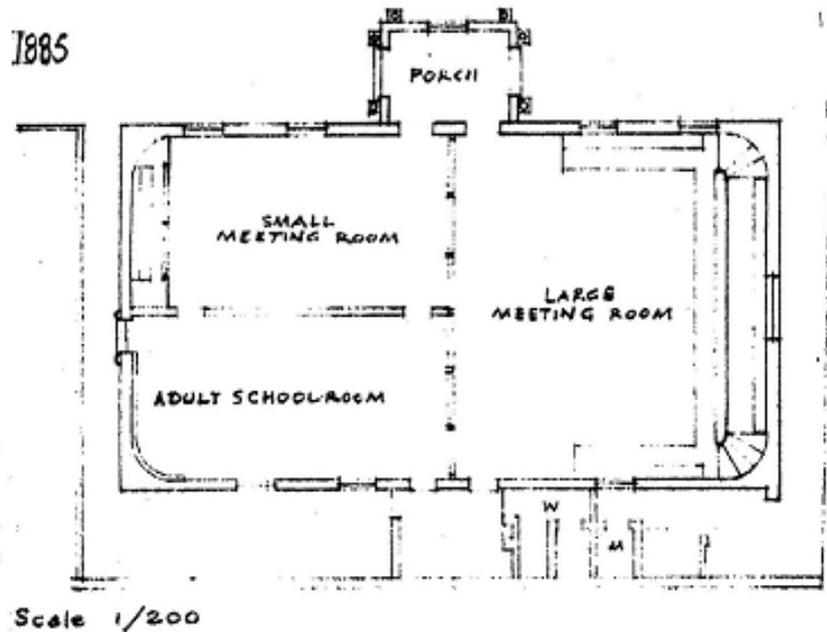
Fig.2 Plan of the meeting house in 1885 from Northampton Local Meeting records. (North is to the top of the plan).
