***Friends Meeting House, Oswestry***

*Oak Street, Oswestry, SY11 1LJ*

***Statement of Significance***

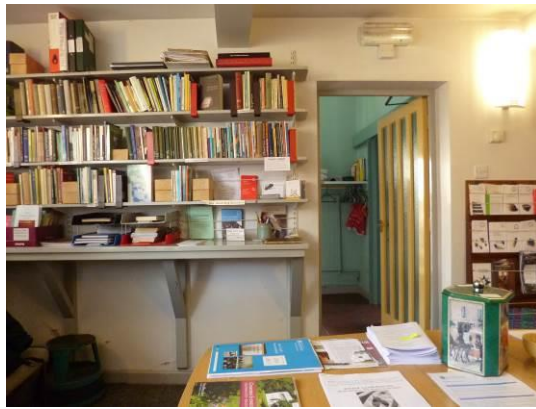
from the modern side porch which leads into a small lobby, part of the 1987 addition; from here stairs lead up to the first floor. A small kitchen is off the west side of the lobby. The ground floor of the 1934 building is used as a foyer and contains a small library (bottom right hand photograph on page 1); walls and ceiling are plain plastered and there are fitted cupboards and shelves. On the north side of the foyer are WCs which retain steel 1930s windows. The meeting room is off the west side of the foyer, with a short ramp from the internal doorway to deal with a change in level; the room is top-lit from the north glazed roof, with a suspended ceiling of translucent polycarbonate panels. The walls are lined with recent timber panelling, and the floor is carpeted. The first floor contains a small meeting room or children's room, plainly finished and lit by windows facing the front and the rear

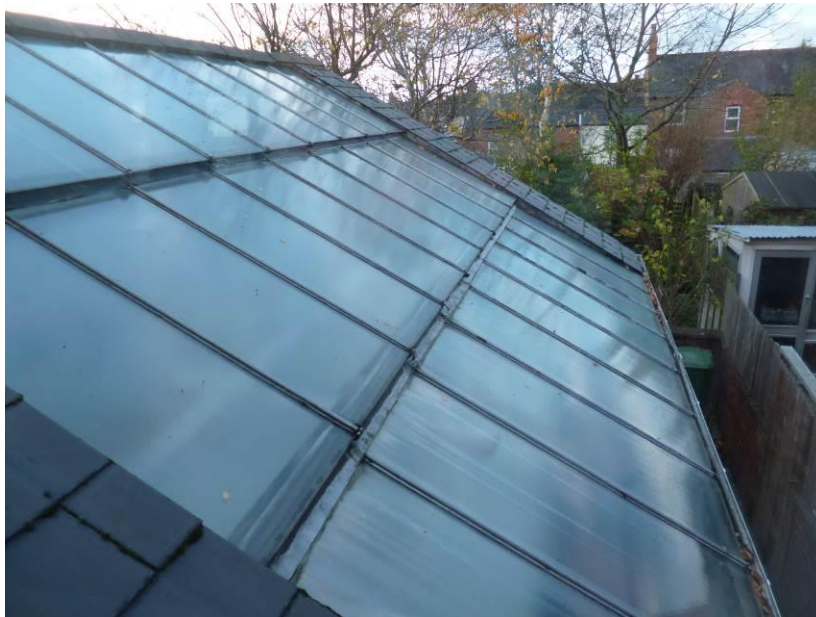
Fig.1: glazed roof over meeting room, formerly a photographic studio
