Former Friends Meeting House, Oxted

5 East Hill Road, Oxted, Surrey, RH8 9HZ

Statement of Significance

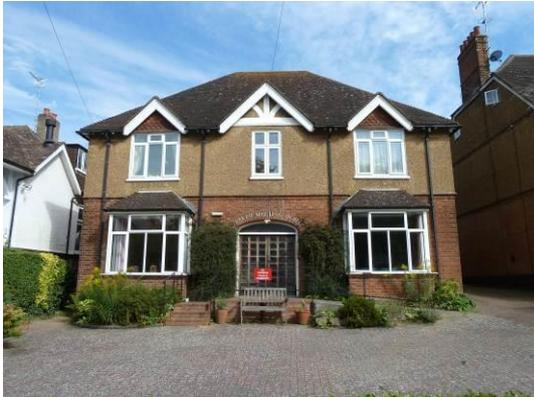
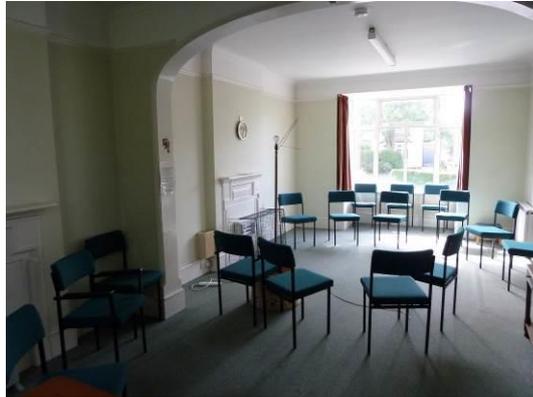
The main elevation faces west. The meeting house has an oblong plan with a small lean-to extension to the rear. The ground floor is faced in brick laid in Flemish bond, while the upper floor is pebble-dashed. The hipped roof is tiled, while the lean-to has a slate roof. All chimney stacks have been removed above the roof. Most of the windows have been replaced in UPVC. The street elevation has three bays. The three-centred arch above the recessed entrance door is flanked by oblong bay windows under half-hipped roofs. The first floor has windows under three gables, of which the centre gable is half-timbered and the outer ones are tile-hung.
