Quaker Meeting House, Ross-on-Wye

3a Brampton Street, Ross-on-Wye, HR9 7EQ

Statement of Significance

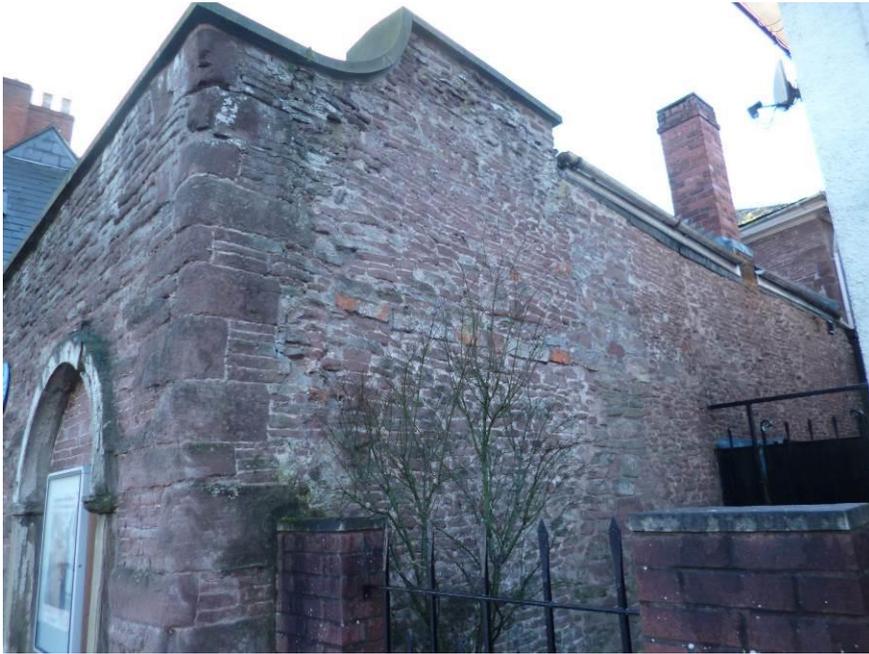
Fig.1: the front screen wall and the north wall of the small meeting room may be part of the earlier meeting house, built in the 1670s

with stone sills and flat heads. The north elevation is blind, with evidence for rebuilding that may relate to the earlier meeting house.

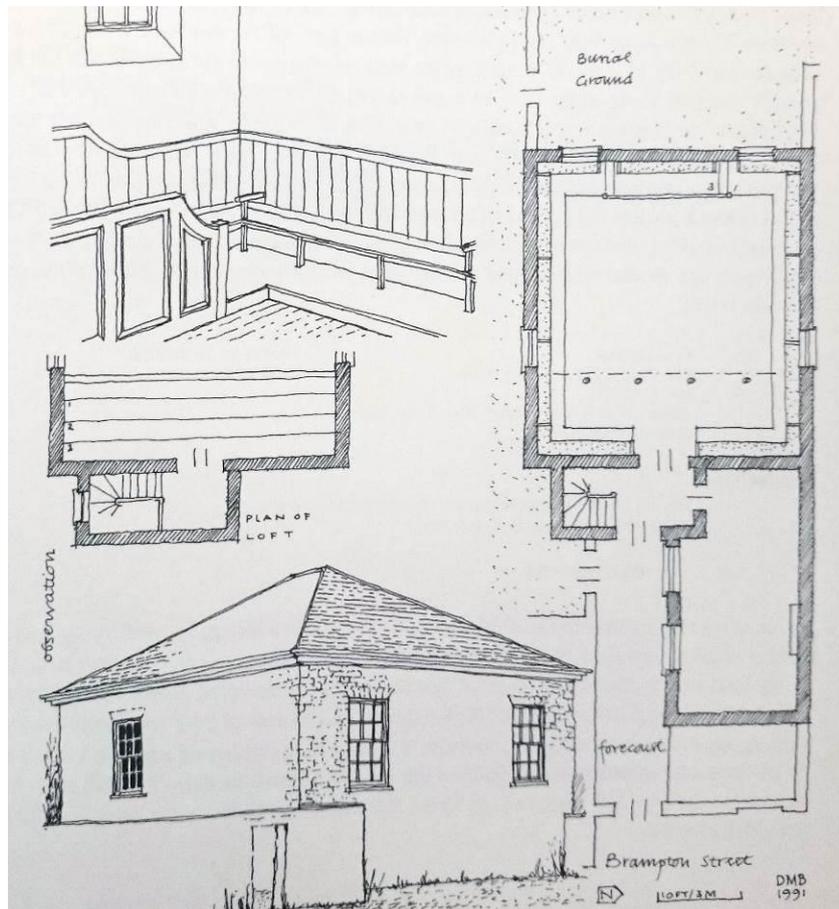
Fig.2: plans and sketches from Butler, 1999, Vol.1 page 249

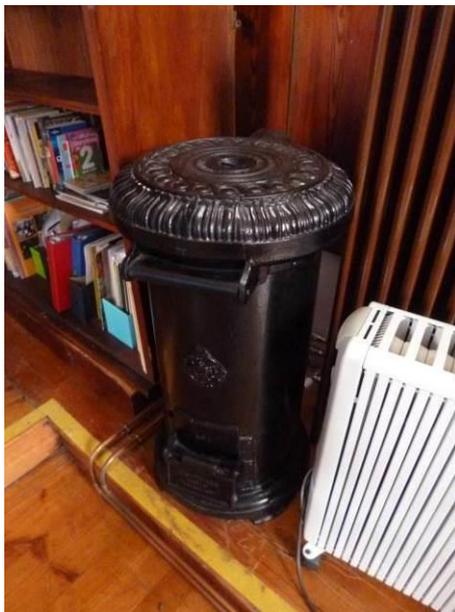
Fig.3: cast-iron stove, ex situ

The interior is entered by the lobby on the east side of the large meeting room; from this double pine doors with fielded panels lead into the large meeting room, the staircase leads of the south and to the north a small lobby leads to the small meeting room. The panelled door from the lobby has been re-set in a stud wall inserted in 2006, to form a disabled WC on the north side of the lobby. The dogleg staircase has pine stick balusters, square newels and elm treads. The large meeting room is a lofty well-lit space with a gallery along the east side, and the ministers' stand to the west. The gallery is supported on four cylindrical timber columns with simple moulded caps and bases; one has been temporarily removed due to structural concerns and a steel prop inserted. The front of the gallery and the stand has pine fielded panels, and walls are lined to dado level with plain vertical pine boards; the top rail swept up behind the stand. The raised platform to the stand continues along the other walls, with fitted pine benches. The walls and ceiling are plain-plastered with a moulded cornice, and the floor is laid with plain pine boards (probably renewed). In the centre is a stone base for a heating stove. The latter is now ex situ but retained in the room.

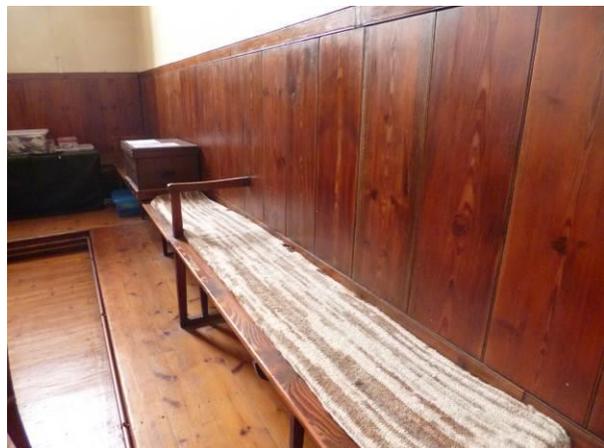
Fig.4: fitted wall benches and pine dado panelling in large meeting room

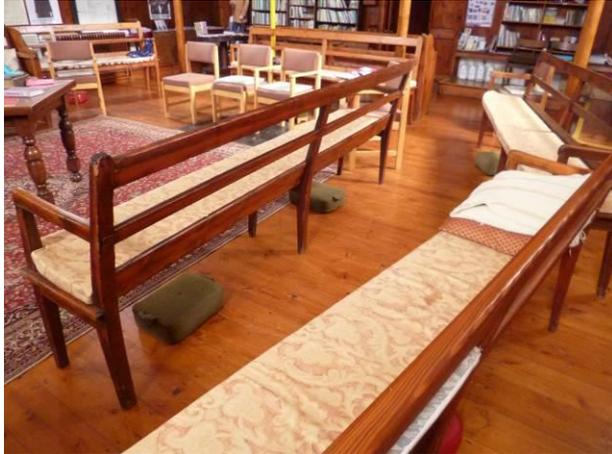
Fig.5: pine benches in the meeting house

Seating in the large meeting room is arranged in a square with a mixture of modern chairs and old benches. There are eight pine benches which appear to be 19th century in date; all have open railed backs, open arms and tapered legs and two have solid bench ends. Lining the walls below the gallery, there are various bookshelves given by Friends, and in the centre of the room either a square oak table of mid twentieth century date or an early nineteenth century circular hardwood pedestal table is used.

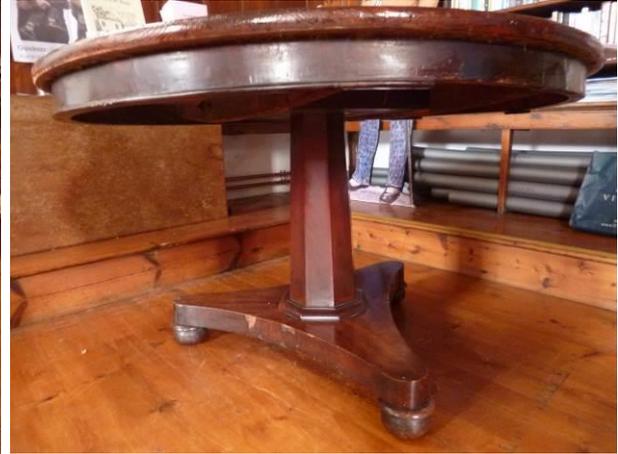
Fig.6: circular table

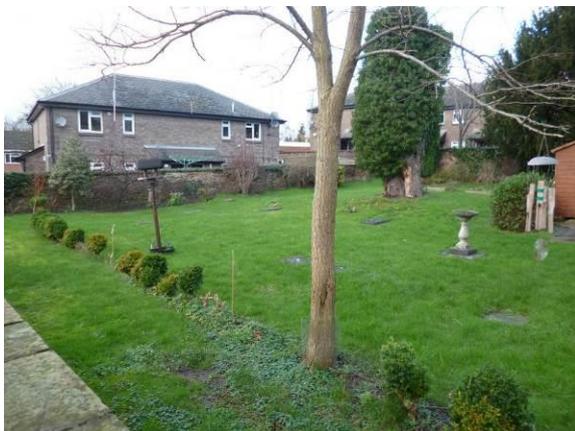
Fig.7: view of burial ground from the south-east

The burial ground dates from the early 1700s and is on the west side of the meeting house, hidden from the street. The L-plan plot is enclosed by stone walls with flat copings, and is mainly laid to grass with a few shrubs and trees, with a small pond for wildlife. A public footpath runs along the south edge of the plot, connecting Brampton Street with the street to the west. The ground is no longer used for burials; the last burial was in the 1920s but ashes are scattered. The burial plots are laid out on a grid, with the rows marked by letters and numbers on small metal plates and inscribed stones set in the boundary walls and the west wall of the meeting house (Fig.7). Burials are recorded on a framed copy of the burial ground plan dated 1823, hung inside the meeting house (Fig.6). The marker stones are all laid flat; the oldest dates from 1765. Prominent local Quakers buried here include Thomas Prichard (died 1843) and Henry Southall who established a weather station in Ross (died 1916).

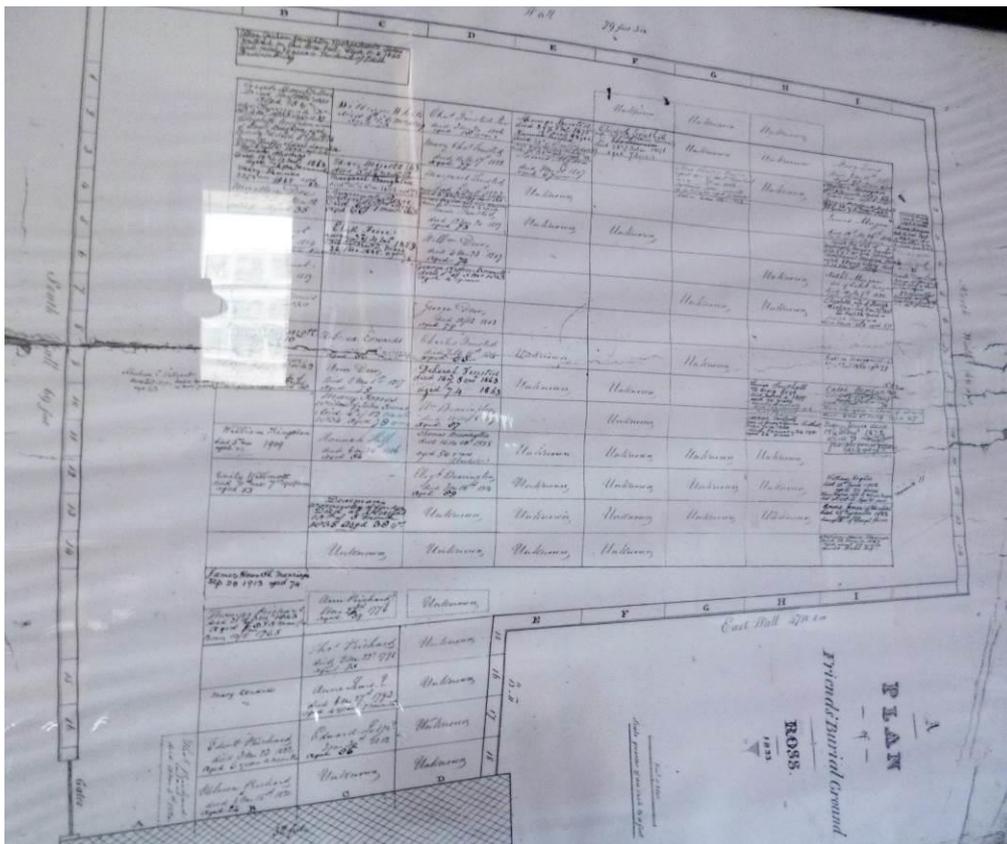
Fig.9: plan of the burial ground, dated 1823
