Quaker Meeting House, Stansted

71 Chapel Hill, Stansted Mountfichet, Essex, CM24 8AE

Statement of Significance

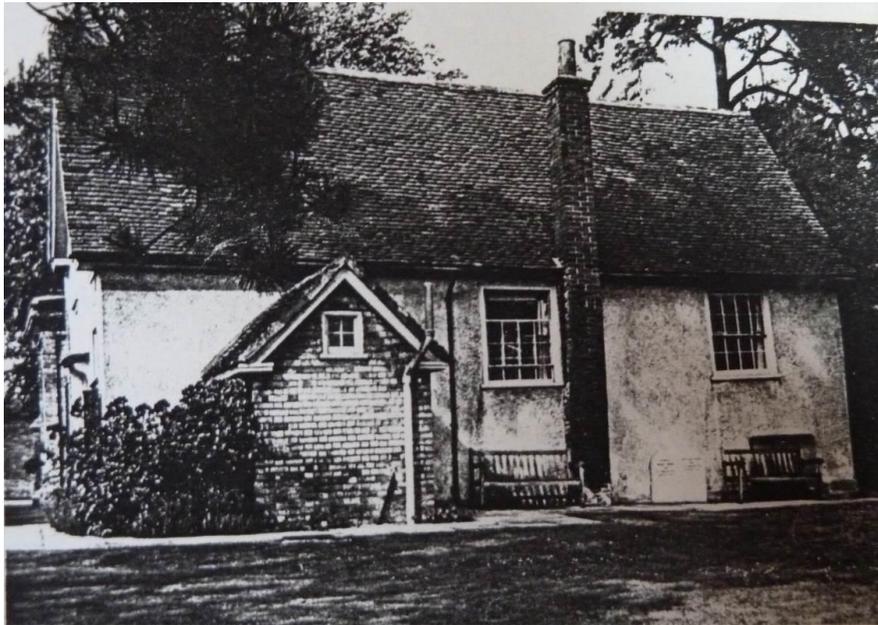
Figure 1: The 1703 meeting house (Stansted Local Meeting archive)

The current site was acquired on 20 August 1703 when a 1,500-year lease was signed. The same year a meeting house was built and a burial ground established. This first meeting house was a timber-framed structure with a cellar (figure 1). It was extended in 1850 and later a new porch was added. In 1929 the meeting closed and the meeting house was used by the Methodists. In c.1955 Hubert Lidbetter described the meeting house as ‘a perfect little building in the best local tradition, ruined by a Victorian extension’.

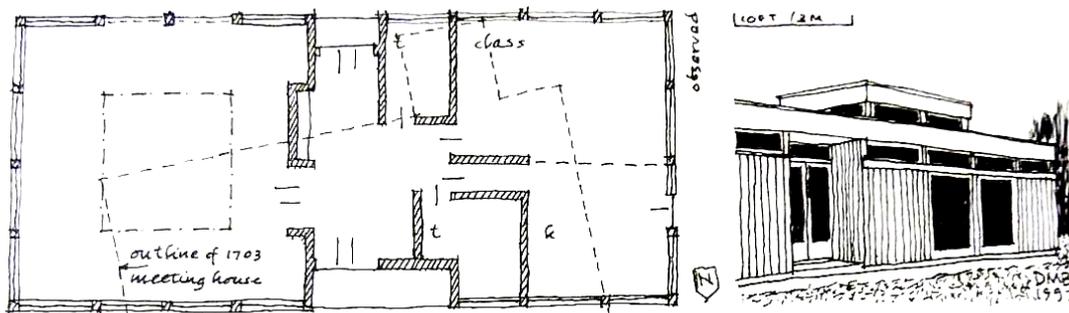
Figure 2: Butler's plan of the present meeting house (pre-1994) with the footprint of the 1703 meeting house superimposed (dotted line) (left) and a perspective of the exterior before the 1990s alterations (right) (Butler (1999), vol.1, p. 200)

The meeting house was constructed in 1967 on the site of the earlier building. It was a prefabricated flat-roofed timber building typical of the era (architect: Paul V. Mauger). In 1994 it was encased in brick, and a pitched slate roof was added. The plan is oblong with the long entrance elevation facing north. The facing materials are brown brick in stretcher bond, with blue engineering in soldier courses for the window lintels and bull-nosed blue engineering bricks for window cills. The north elevation has four windows and one dormer and a gabled, timber-panelled entrance porch.
