Friends Meeting House, Tavistock

4 Canal Road, Tavistock, Devon, PL19 8AR National Grid Reference: SX 48021 74176

Statement of Significance

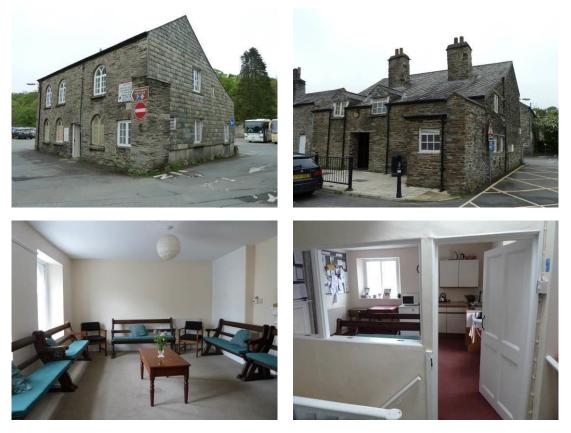
The meeting house was built from local rubble stone with Gothick windows, matching those on the nearby wharf building (5 Canal Road). It has been altered externally and internally over time but the main elevation in particular retains medium aesthetic value.

The plan is oblong. The cottage was built using rubble stone. (By the 1950s and 1960s this was rendered.) The roof is of slate and the southwest elevation is slate hung. The roof is pitched with an outshut to the rear; the two chimneystacks are on the rear slope of the roof, between the main rooms and the outshut. (Two further stacks to the outshut are visible in photos of 1969.) The front (northwest) elevation is of two storeys and five bays, with the current entrance in the centre. Most of the windows have Gothick Y-tracery casements and arched heads of thin slabs of stone laid on edge. The windows in the east bay have brick arches, while the door and the only window in the west bay (a former door) have segmental heads of stone on edge. (In the 1950s and 1960s, the window in the former door opening still had a lean-to canopy.) Attached at the west corner is a rubble gate post. The southwest elevation has two windows to the first floor and two to the ground floor (as well as a modern ventilation grille). The rear (southeast) elevation has the entrance to the public toilets under two slate-hung dormers; there is a small flat-roofed extension near the east corner. The latter abuts a slate-coped wall to the east which continues the line of the northeast side elevation. The only windows on the northeast elevation are two ground-floor windows and one firstfloor window to the outshut, all under modern lintels.
