Friends Meeting House, Wallingford

13 Castle Street, Wallingford, Oxfordshire, OX10 8DL

Statement of Significance

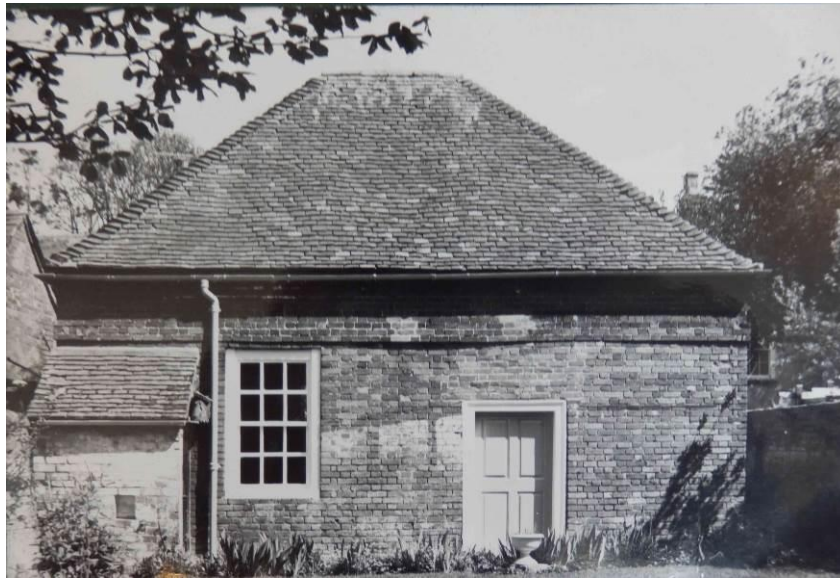
£10,000, which was grant-aided). A small rear outbuilding (visible in figure 1), first shown on the 1899 Ordnance Survey map, was demolished in the late twentieth century.

Figure 1: Undated photo of rear elevation (Local Meeting archive)
