## **Quaker Meeting House, Welwyn Garden City**

109 Handside Lane, Welwyn Garden City, Hertfordshire, AL8 6SP

### **Statement of Significance**

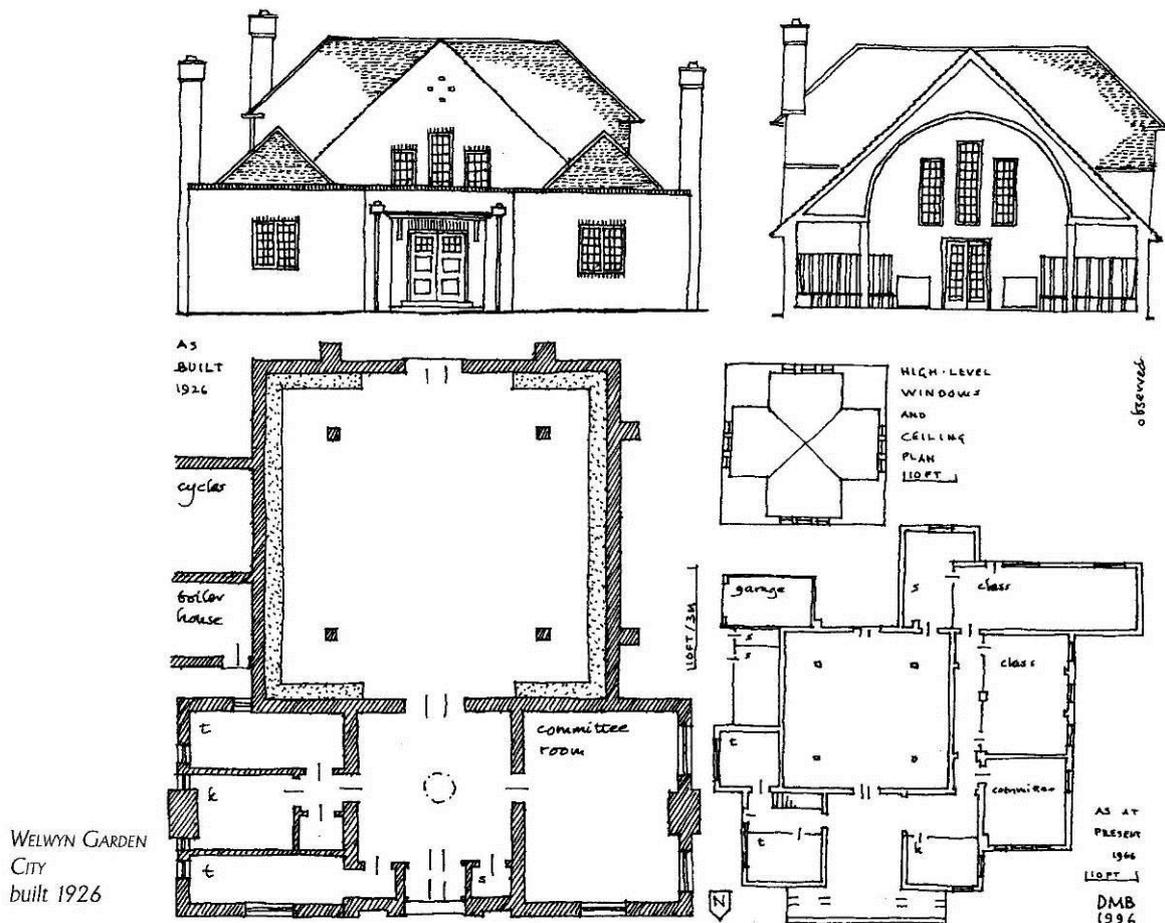
Fig.1 The original main front and a section through the meeting room, with the original ground floor plan and a plan showing the enlargement by the mid 1990s. *Butler vol.1 p.269* (Butler's compass direction is wrong: north is to the left of the plans)

Lander's original meeting house (fig.1) was a vaguely Arts & Crafts vernacular style building comprising a large square meeting room with a lower fore-building containing toilets, a small kitchen and a small meeting room either side of an entrance lobby. As a result of later alterations, in particular the addition in 1968 of a tall pitched roof over the fore-building to contain a warden's flat, and the replacement of most of the original small-paned windows, the original character of the building has largely been lost.
