Quaker Meeting House, Worthing

34 Mill Road, Worthing, West Sussex, BN11 5DR

Statement of Significance

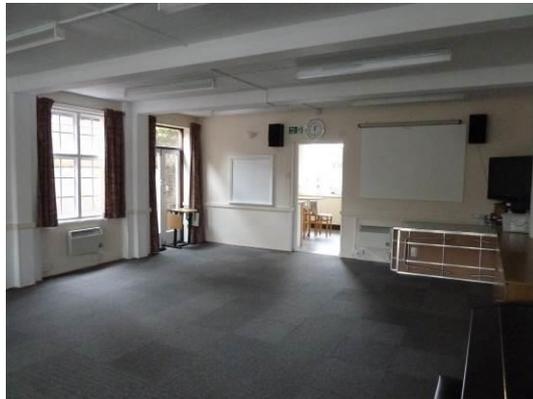
The large downstairs room, which would have been the garage and boathouse, has prominent ceiling beams (photo bottom right). To the north is the kitchen and toilets; further toilets and a small meeting room are in the east extension. A stair just to the east of the main ground-floor room leads to the upper floors. On the first floor there is a landing (which also serves as the library) with woodblock floor and the attic stair. The meeting room occupies the large room on the first floor (photo bottom left). This also has a woodblock floor as well as a plain skirting board and picture rail. The upper parts of the doors between lobby and meeting room have leaded small-paned glass panels. The attic has walls of Fletton brick, timber posts between the floor and the purlins, and large beams on top of the boarded floor which are strengthened by iron plates on either side.
