## ***Friends Meeting House, Yealand***

*18 Yealand Road, Yealand Conyers, Carnforth, LA5 9SH*

### ***Statement of Significance***

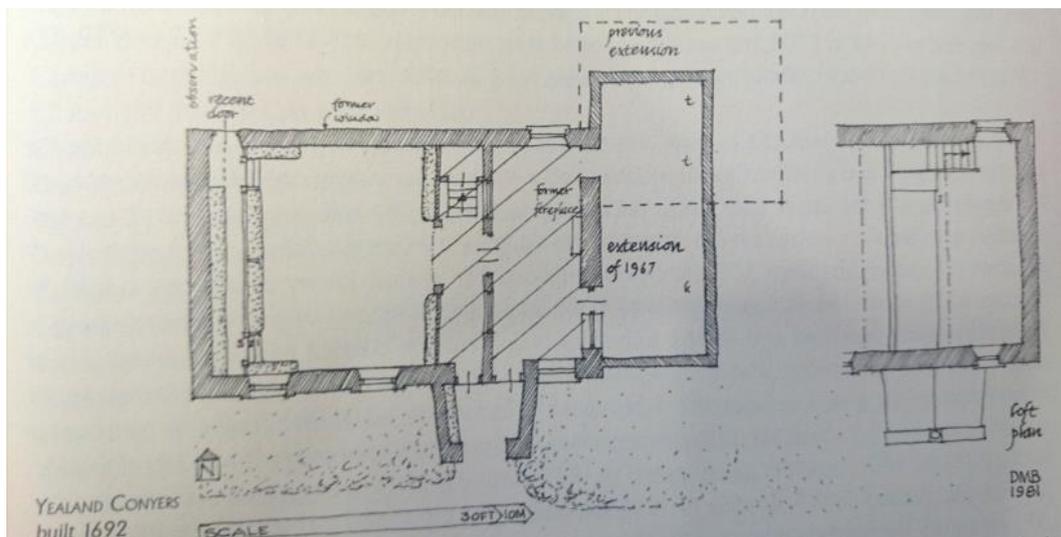
Figure 1. Ground floor plan of the meeting house as reconstructed by Butler (north at the top; not to scale) (Butler (1999), vol. 1, p.349)

Interior. The fixtures and fittings could date to the refurbishment which took place after the 1734 fire, or may be of later eighteenth century date. The building conforms to a plan type in which a passageway entered from the west doorway runs beneath the gallery and divides the men's from the women's meeting rooms, and has a stair to the gallery at the far end. This tripartite plan-form has resonances with the plans of contemporary vernacular houses. The corridor partitions are panelled and incorporate shutters which could be raised to throw the whole ground floor in to one space. Hooks in the women's meeting room ceiling were used to secure the hinged shutters and wooden hat pegs survive in the corridor. The main meeting room is lined with raised and fielded panelling to dado height and is overlooked by the gallery on the east side with a panelled front above the screen, which has fluted pilasters framing the opening from the passageway. Two wrought-iron lamp brackets fixed to the gallery front are probably of early twentieth century date, executed in seventeenth century style. At the west end of the room there is a stand which is divided from the room by a long fixed bench with panelled back and bench ends treated as handrails. These serve steps which lead up on each side. The panelling and fixed furnishings have a grained finish and probably of pine. The stair is simply treated and the gallery is tiered. The women's room retains a panelled draught screen beside the door. Most exposed walls are plastered and scribed to resemble large blocks of masonry. The building survives as a good example of a meeting house with seventeenth century origins and a fine eighteenth century interior.

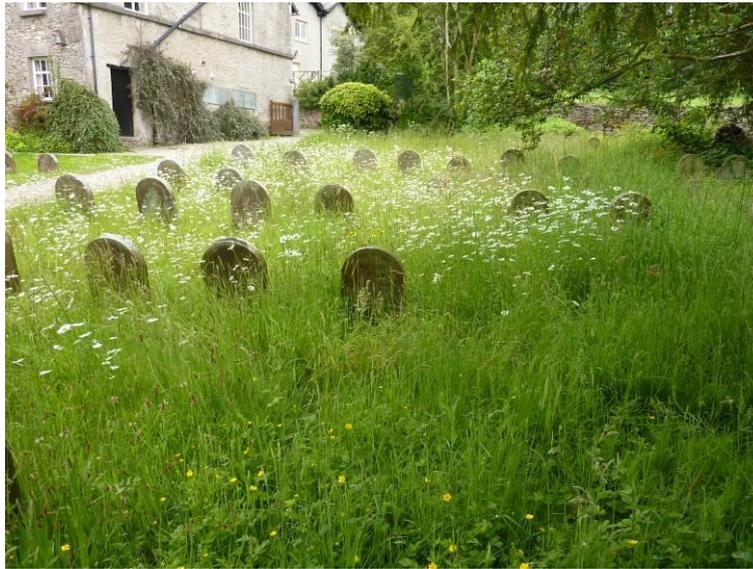
Figure 2. The burial ground

The meeting house is enhanced by having a little altered setting in an attractive burial ground. The burial ground is on three sides of the meeting house, and is enclosed on three sides by limestone walls. It abuts the former schoolhouse and a pair of cottages on the south side. Headstones are *in situ* and range in date from 1821 to 1989. The author Elfrida Vipont Foulds (1902-1992) is buried in the yard, as is Thomas William Worsdell (1858-1915) a noted locomotive engineer. Handwritten burial records are kept by the meeting. The burial ground is subject to routine maintenance and maintained as a wildlife garden.

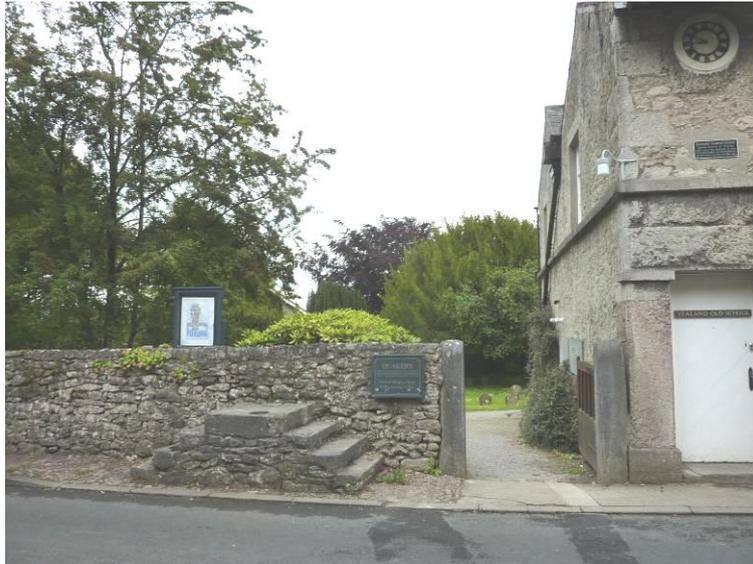
Figure 3. The entrance to the burial ground showing the mounting block and part of the former school building.

Mounting block, date uncertain. Large limestone blocks with rubble base. 3 steps on each side of a central platform.
