Friends Meeting House, Airton

Airton, Skipton, BD23 4AE

Statement of Significance

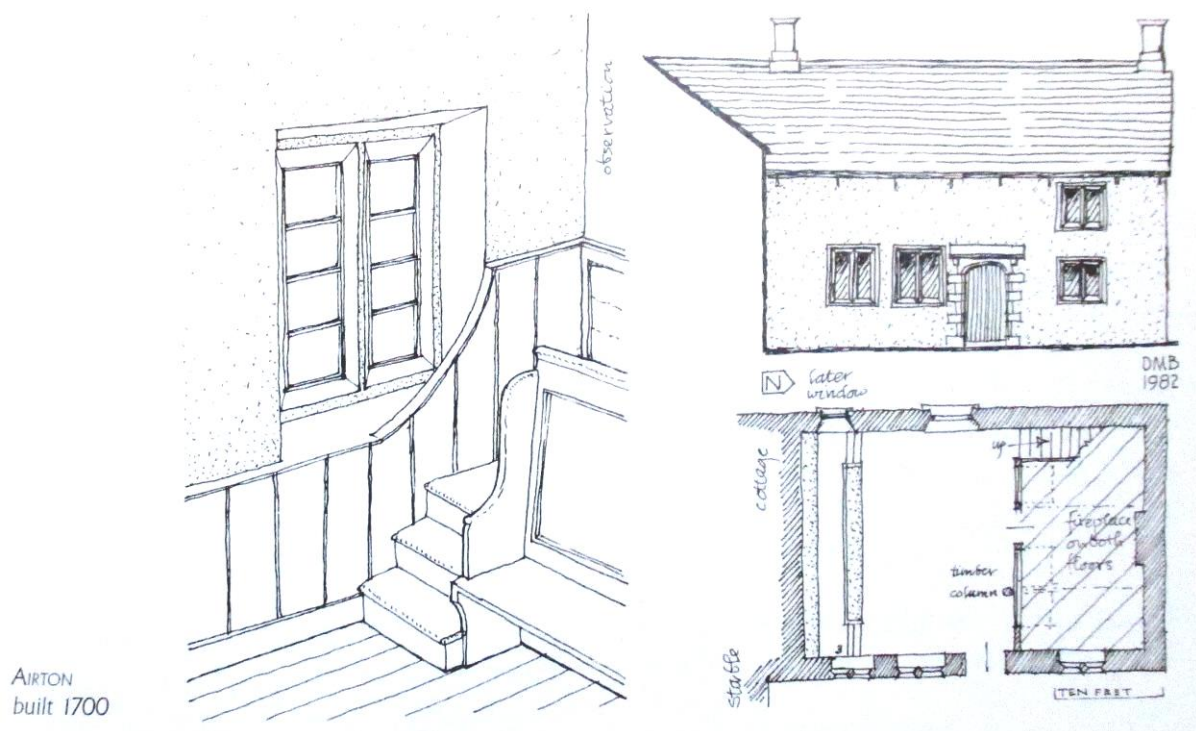
Fig.1: Plan and sketches by Butler, 1999 (p775). North is to the top right.

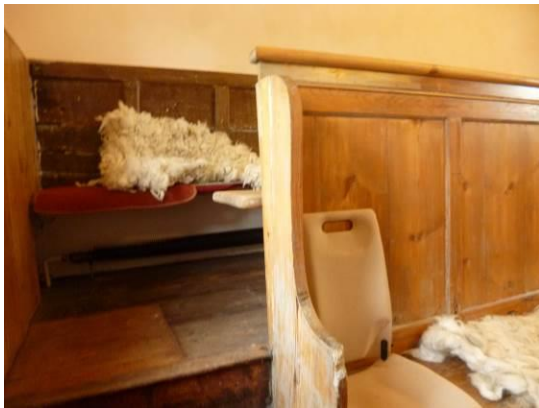
The meeting house interior is divided into two unequal spaces with the main meeting room to the south-west. The stand is against the south-west wall; this has oak panelling to the rear dado, end steps, a fixed pine bench to the front, and pine tongue and grooved dado to side walls, ramped to the stand; the pine joinery appears to be early nineteenth century in date, but the oak panelling is earlier. The smaller meeting room to the north-east is separated by a simple horizontally boarded oak screen with top-hung hinged shutters. Narrow stairs in the north-west corner lead to the gallery; the gallery floor is supported on a pair of chamfered posts and two chamfered beams with exposed joists and the gallery front is plainly panelled. The matching stone fireplaces on both floors, each have chamfered arrises and deep chamfered cornices. These fireplaces and the oak joinery are typical of the late seventeenth century. The ground floor fireplace has a nineteenth century cast-iron grate. Walls and the flat ceilings are plainly plastered with lime-wash finish. Floors are boarded in pine. The 3-bay roof has two tie-beam trusses with struts; one has curved principals.

Fig.2: stand with fixed benches of varying dates

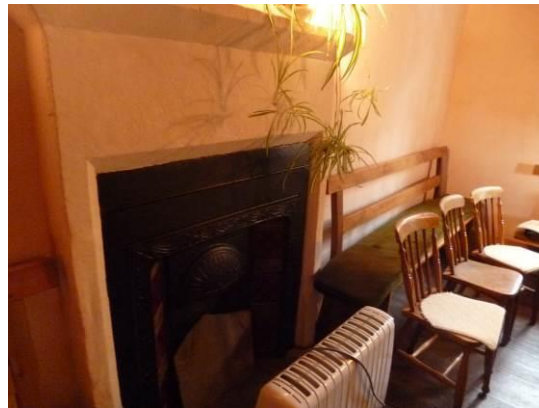
Fig.3: one of two stone fireplaces in the smaller rooms to the east end

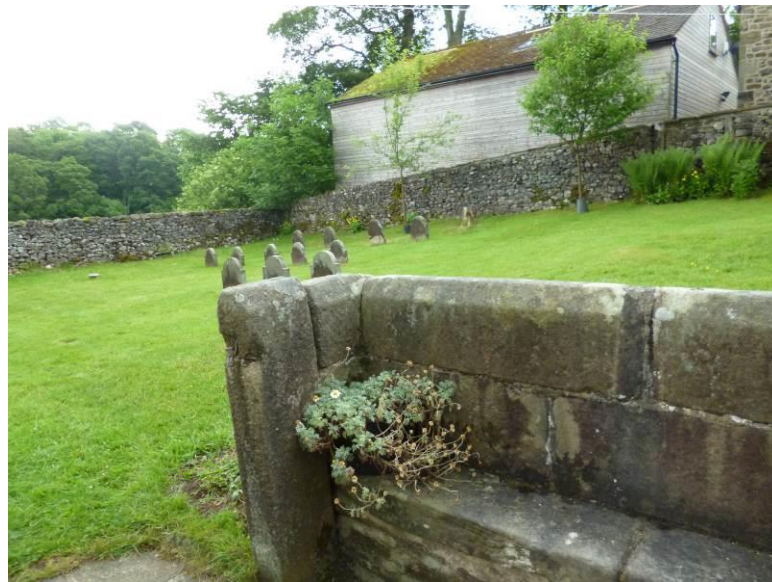
Fig.5: burial ground and stone bench set in wall, from the west

The sloping burial ground adjoins the meeting house on its south and east sides, enclosed by drystone walls. The roughly L-plan area is laid to grass with rows of head stones towards the east end; the stones have arched tops in the usual Quaker style, dating from the second half of the nineteenth century. A low ashlar wall separates the paved yard on the south-east front of the meeting house from the burial ground; the wall has an integrated stone bench to the side facing the meeting house and the top of the wall is chamfered. This unusual feature is hard to date; it is said to be seventeenth century in date, but may be later. A gateway with flat
