Quaker Meeting House, Alton

39 Church Street, Alton, Hampshire, GU34 2DA

Statement of Significance

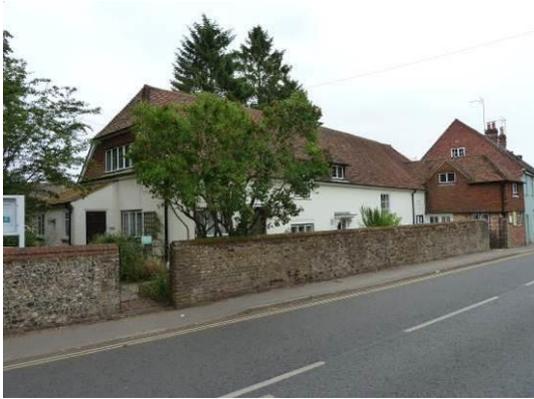
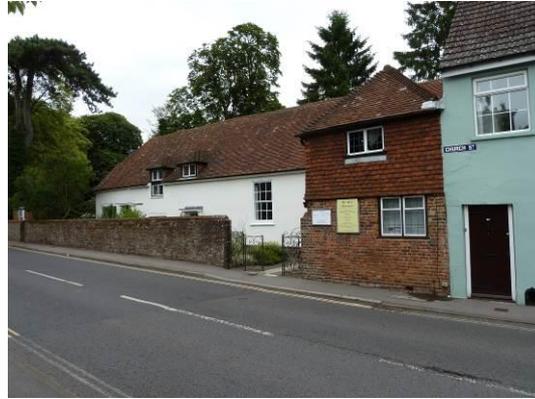
Parallel with the meeting house and to the west is the boundary wall of brick (photos top left and right) with black headers which spell out '1672', the date of the meeting house and burial ground. The two wrought iron gates are modern. There is a narrow yard on the east side of the meeting house.

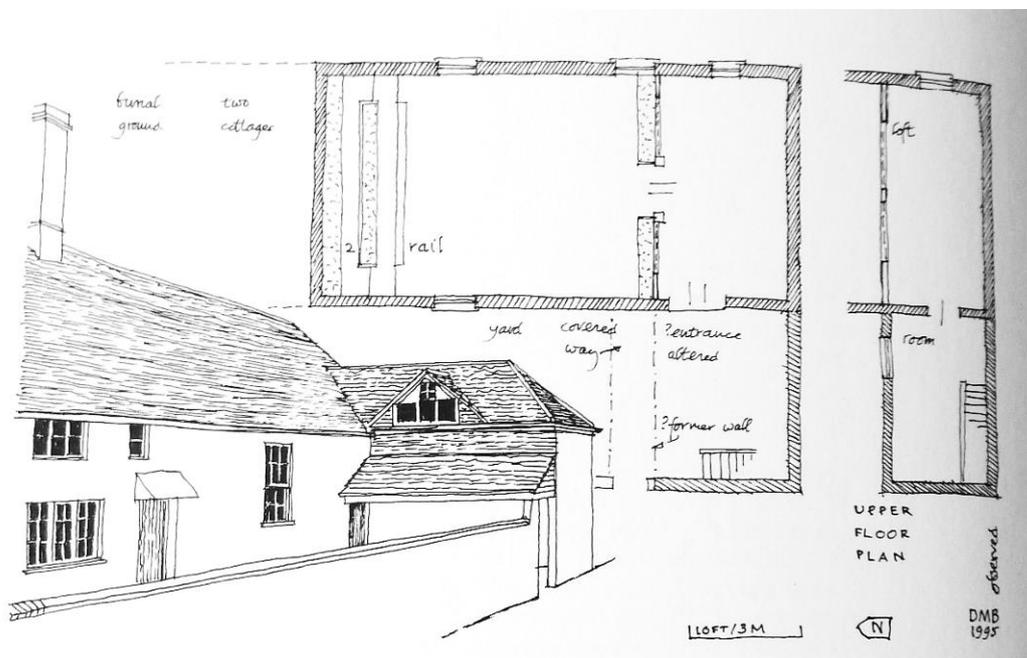
Figure 1: Perspective, ground and first floor plan (Butler (1999), vol. 1, p. 228) (North is to the left, not to scale)

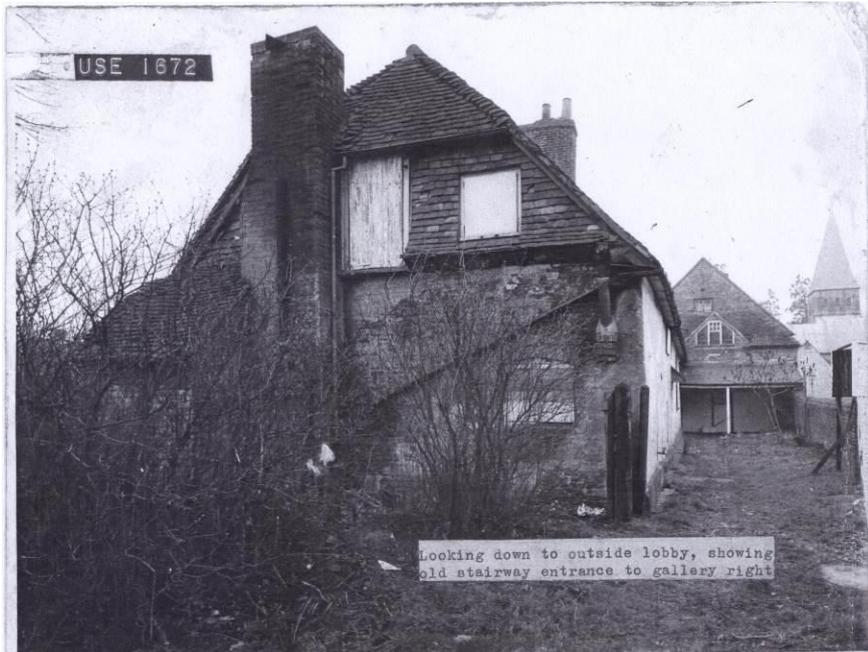
Figure 2: The meeting house in c.1960, seen from the north
(Alton Local Meeting Archive)

dormers. The cross wing's former open lean-to porch has been removed and the north wall rebuilt using second-hand bricks. It has casement windows to the west and north elevation, with the dormer window to the north having been altered (see Figure 2). Compared to historic photos (Figure 2), the fenestration of the north elevation has been altered and a chimney stack removed. Apart from the timber sashes, the windows are metal-framed casements with internal secondary glazing.

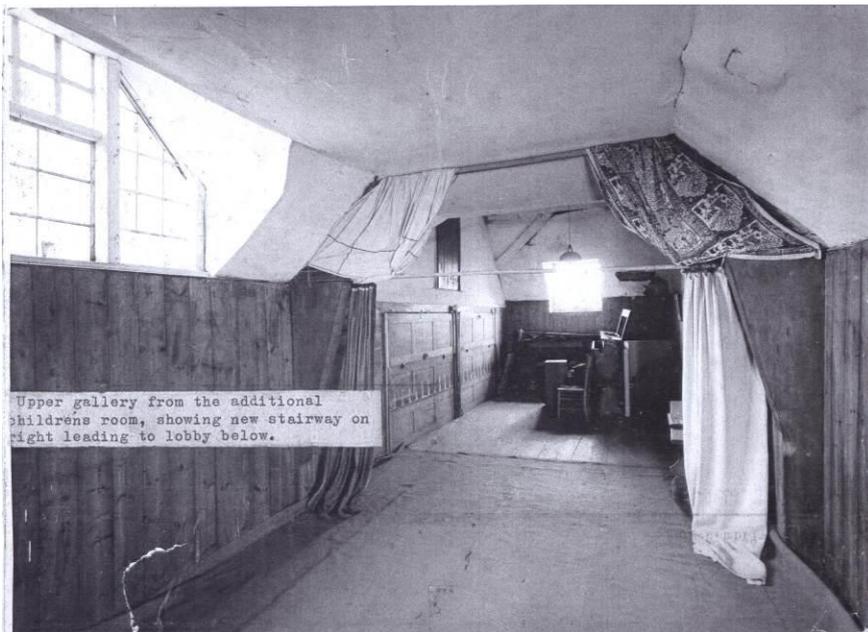
Figure 3: The south gallery with shutters, looking east, in c.1965
(Alton Local Meeting Archive)
