Friends Meeting House, Cardiff

43 Charles Street, Cardiff, Glamorganshire, Wales, CF10 2GB

Statement of Significance

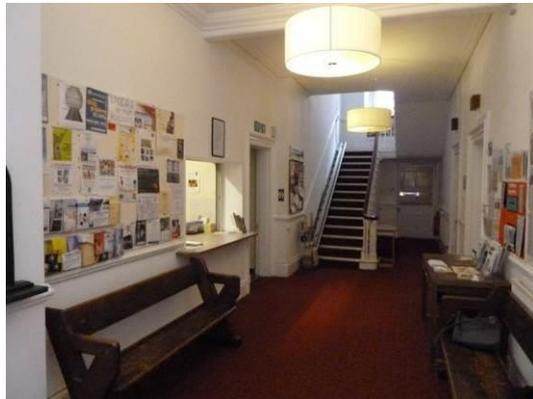
The entrance is via a recessed bay to the north, with decorative leaded glass above the inner door and a modern skylight. This leads into the wide corridor which occupies the rear of the main wing. It contains a small fireplace and the large open-string staircase at the south (photo bottom right on page 1) which has a cast-iron newel, turned balusters and a mahogany handrail. The meeting room occupies the two former rooms to the front of the building (photo bottom left on page 1) which still retain their Victorian chimneypieces. The ground floor of the rear wing has the current kitchen (with a large window with original shutters), the small service stair and toilets. The first floor has five rooms, one of which retains its corbelled chimney piece. The second-floor rooms were until the 1990s the warden's flat but have been converted to four rooms and one lavatory. The basement was not inspected.
