## ***Friends Meeting House, Diss***

*10 Frenze Road, Diss, Norfolk, IP22 4PA*

### ***Statement of Significance***

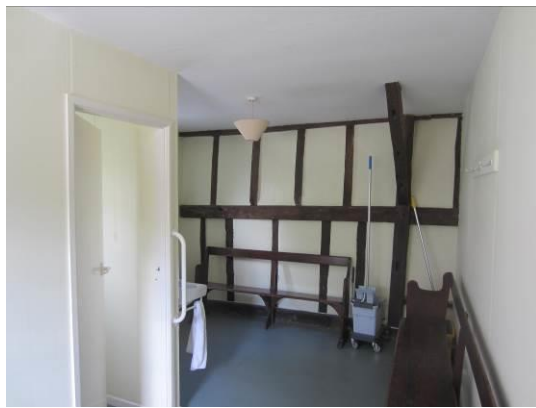
benches. The underside of the gallery was enclosed with a pine partition in the 1980s to form a lobby. Originally there was a corresponding gallery on the east side. That has been removed, as has the stand (the 'lectern platform' mentioned in the list description) which had been relocated to this position from its original position on the north side, possibly in 1903. The panelled dado here is of Georgian character, whereas elsewhere it consists of vertical matchboarding of nineteenth or early twentieth century character. There are further meeting rooms and a kitchen in the late nineteenth/early twentieth-century additions; in the former stable block attached to the northeast (now WCs) much of the timber framing is exposed (photo bottom right, p. 1).
