## ***Friends Meeting House, Eastbourne***

*17 Wish Road, Eastbourne, East Sussex, BN21 4NX*

### ***Statement of Significance***

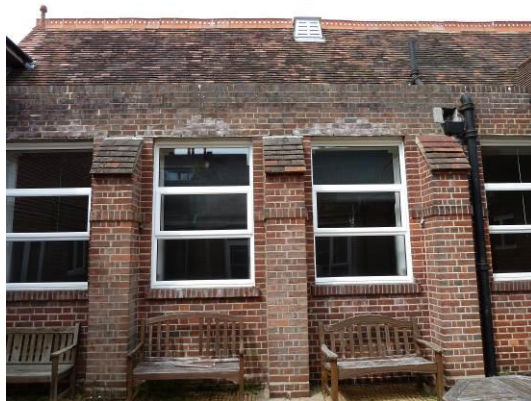
The building faces west. The plan is of four ranges around a central courtyard. The west front is a two-storey flat-roofed block of 1951-2 faced in brick in stretcher bond. The windows (all now replaced in UPVC) have projecting surrounds, as does the recessed central entrance and the recessed entrance to the flat at the south. On either side of the entrance are three windows (two square windows, one oblong), while the first floor has four windows of four lights each. The meeting house wing retains some of the Victorian appearance of its tiled, pitched roof with decorative ridge tiles and a truncated ventilator stack (see photo bottom

right). The south wall of the meeting room (facing the courtyard) was largely rebuilt in 1938-9 with a brick wall with parapet and buttresses between the four windows. The east courtyard block also has a pitched tiled roof supported on two timber posts with braces, which forms an open loggia in front of a small brick block with metal windows (now a store, in 1939 gents' toilets). The flat-roofed single-storey south wing dates from the 1930s and was partially rebuilt in 1951-2. The brick here is laid in stretcher and Flemish bonds with soldier and rowlock courses above and below the windows and the parapet. It has two windows and a door into the courtyard. Its roof is used as a roof garden for the flat. The courtyard is paved in yellow pavers in herringbone pattern.

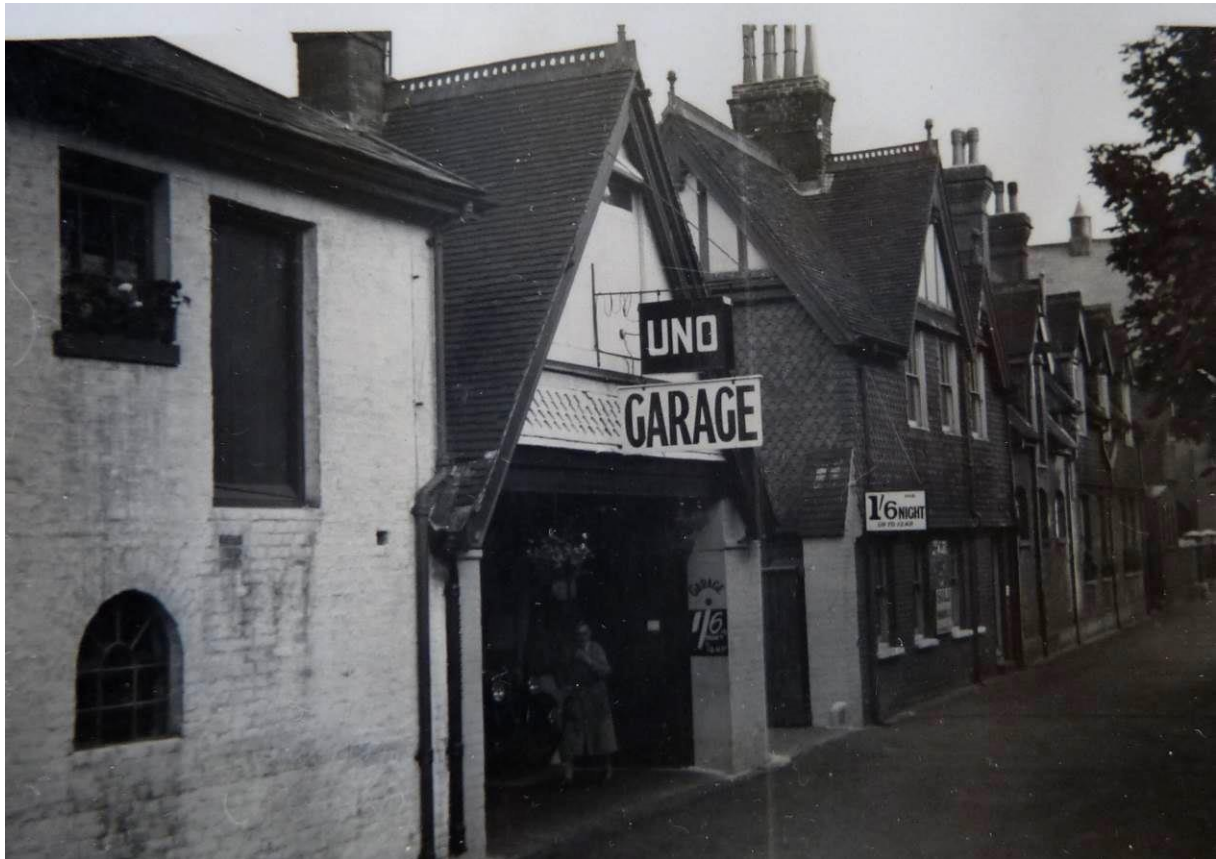
Figure 1: The garage and house in Wish Road in 1938 (Local Meeting archive, minute book)

Meetings for Worship were held in Eastbourne since 1910. The current site was acquired in July 1938 by the Quakers. It was then occupied by a house and two garages ('UNO Garage') in a former stable building, all grouped around a courtyard (Figure 1). According to map evidence, the buildings dated from between the 1870s and 1899. The architect H. Hubbard Ford and the builders Mark Martin & Son converted one garage into a meeting room and the

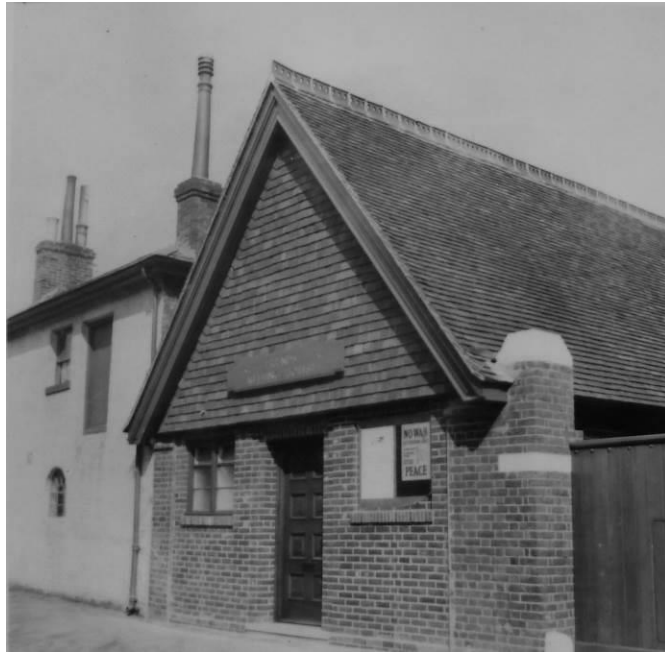
Figure 3: The west elevation of the meeting house in 1939  
(Local Meeting archive, minute book)

other into a children's classroom and kitchen (Figures 2, 3). The meeting house opened in 1939. The house was let.

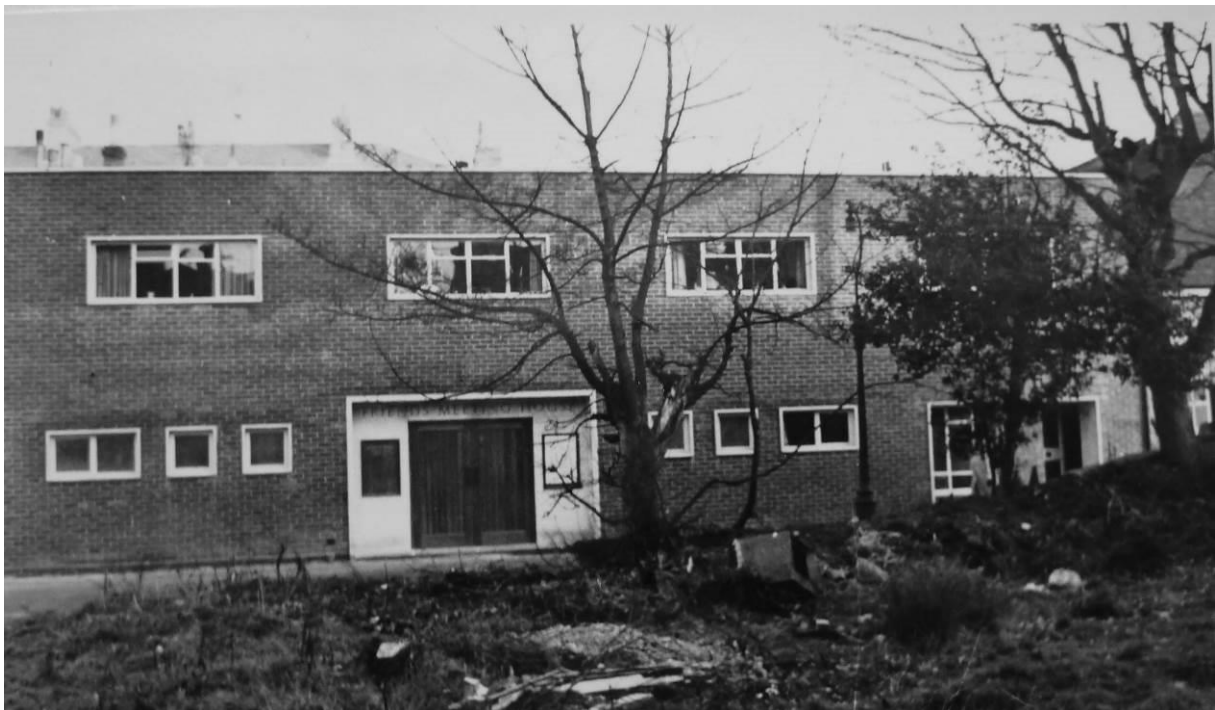
Figure 4: The new west elevation in November 1952  
(Local Meeting archive, minute book)

During the Second World War and particularly during April 1943, the meeting house and the cottage sustained severe bomb damage. In 1951-2, the meeting house and cottage were partially rebuilt by the architect H. Hubbard Ford (builders: G. Gower & Sons). The entire west front was rebuilt as a two-storey flat-roofed block which included a first-floor flat (Figure 4). The eastern part of the meeting room, the courtyard and the children's room remained largely unaltered.
