Friends Meeting House, Harlow

1 Church Leys, Harlow, Essex, CM18 6BX

Statement of Significance

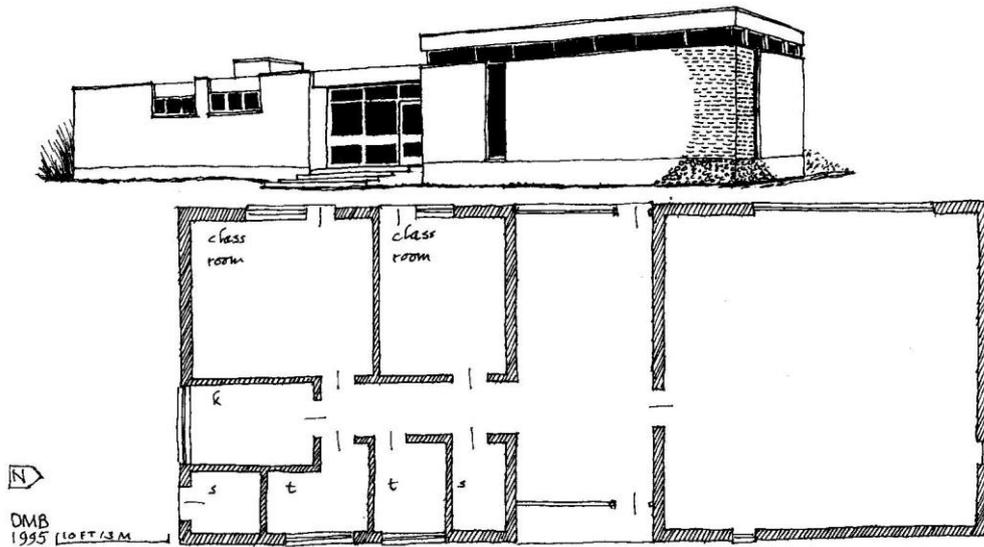
Fig.1 The ground plan and perspective view of the original building from *Butler* vol 1 p.189

The building is single storeyed with a flat roof. The walls are faced with brown brick laid in stretcher bond; the roof is covered with mineral felt. The plan is a rectangle, with the meeting room at one end, separated from the other spaces by a wide internal lobby. The meeting room is raised slightly above the rest of the building with a strip clerestorey on all four sides. The rear elevation facing the substantial garden has large windows with French doors, now mostly replaced in uPVC. The interior of the meeting room is simply fitted, with cork-tiled floors, plain plastered walls and the concrete ceiling beams exposed.
