Quaker Meeting House, Hereford

21 King Street, Hereford, HR4 9BX

Statement of Significance

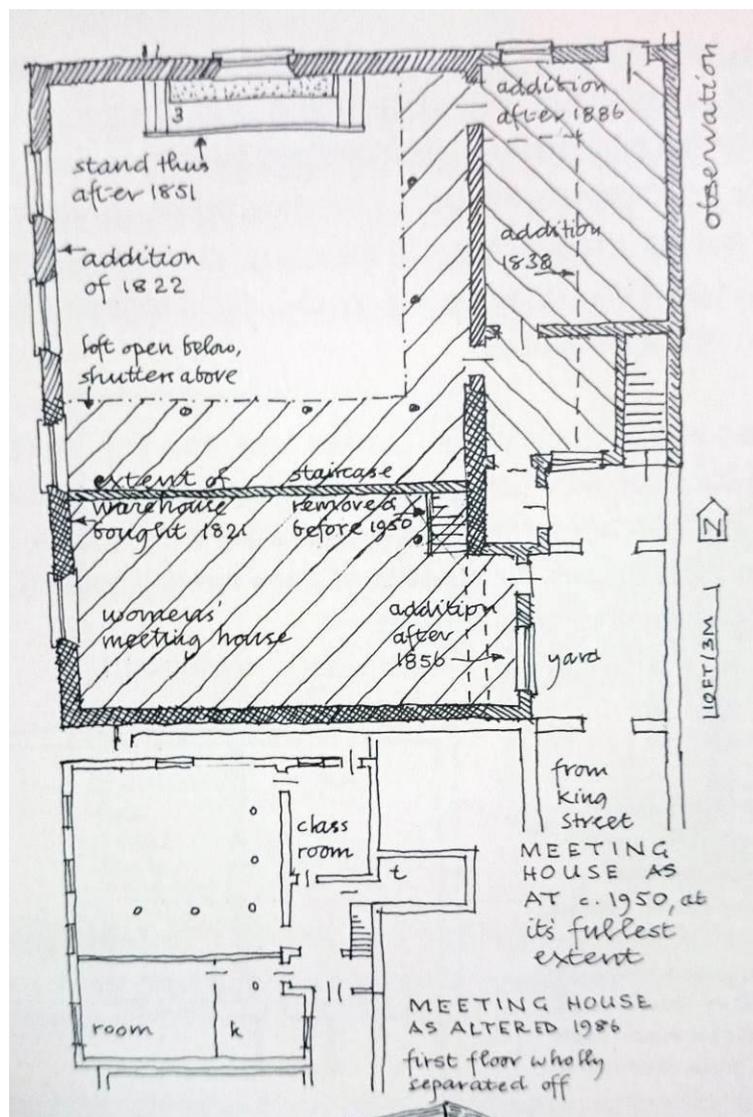
Fig.1: plan as reconstructed by Butler (1999, p. 246)

1821 the meeting acquired the site off the north side of King Street, which is said to have been partly occupied by a flannel manufactory, of late eighteenth or early nineteenth century date. Butler notes that this building corresponds with the south part of the present building. Quakers extended this by building a full-height meeting room on the north side in the 1820s. A narrow addition was built on the east side of the meeting room in 1838, extended again in the late nineteenth century to provide a lobby, staircase and a class room. The high iron gallery front was installed around 1851. From c.1958 the first floor was let, with separate staircase access. In the 1960s, some remodelling took place, when the wall between classroom 1 and the main meeting room was moved southwards to its present line, a new staircase, porch and WCs were installed and the solid fuel stove was replaced with electric heaters. The lobby was extended in the 1980s and a suspended ceiling installed in the meeting and a kitchen was provided. In 2009, the first floor tenants inserted a mezzanine floor, designed by Ken Pearce of JBD Architects.

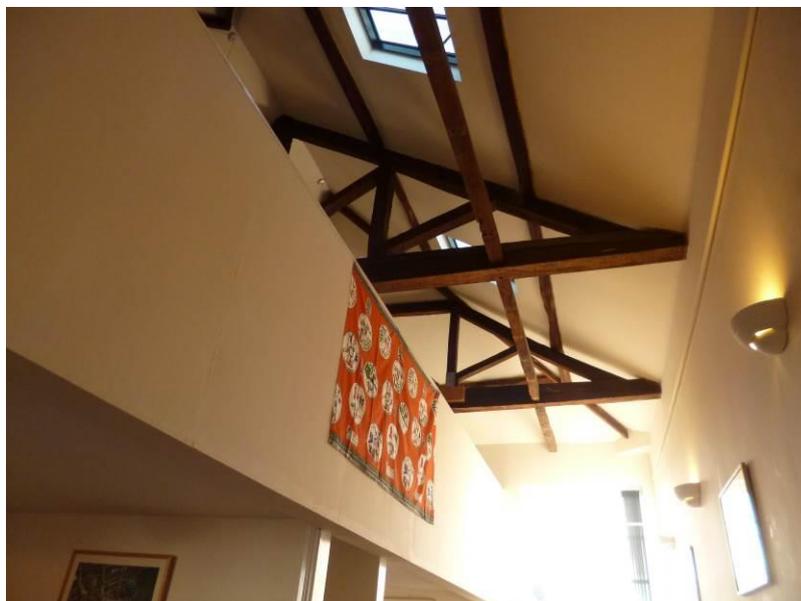
Inside the meeting house has been altered with inserted partition walls and suspended ceilings which obscure some of the historic details and hindering interpretation. The main meeting room has a carpeted solid floor, a suspended ceiling and is lit from the north and west. It retains some early nineteenth century features including reeded architraves and flush beaded panelling to the north wall (formerly the location of the ministers' stand). Other walls have tongued and grooved dado panelling, with some re-set flush panelling above. The main feature of the room is the very high gallery on the south and east sides, carried on slender cast-iron columns with a quatrefoil section, an unusual feature for a meeting house. The gallery is blocked off from the room, but the retained front has panels of gothic iron balustrading, possibly re-set from another building, such as a church. The smaller meeting room to the south of the main meeting room was formerly the women's meeting room and is lit by a large sash window from the west. It has some tongued and grooved dado panelling, a Tobin tube for ventilation and a twentieth century plaster cornice. On the first floor of the south range, the 4-bay roof structure with tie-beam trusses is partly exposed above the inserted mezzanine.

Fig.2: exposed roof in south range, from east (in office use)

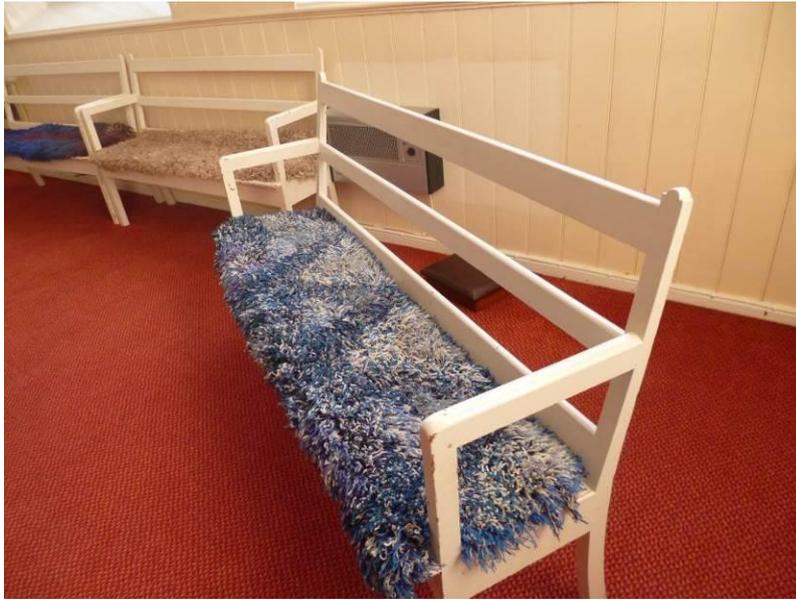
In the main meeting room, the seating consists of painted pine benches and modern chairs, arranged in a loose circle.

Fig.3: painted pine benches in the meeting room

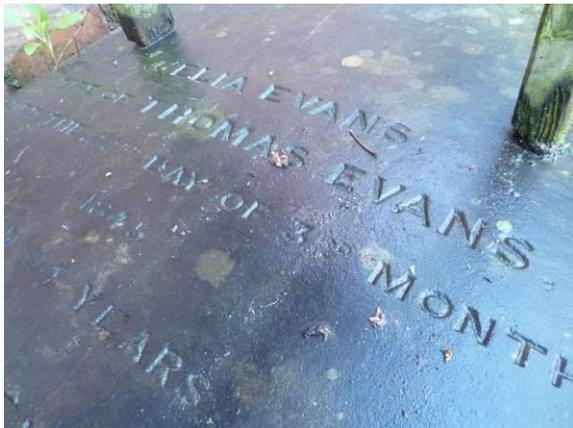
Fig.4: large grave slab to Celia Evans died 1845

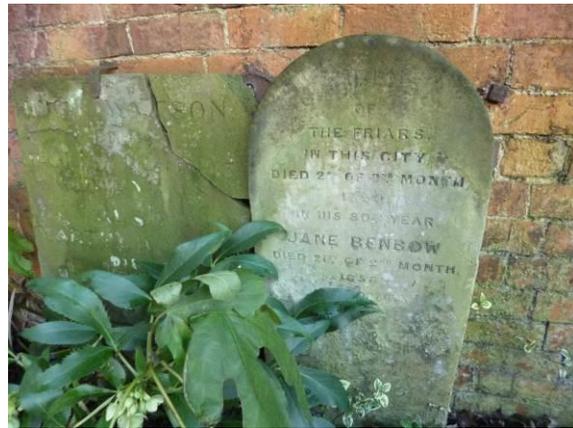
Fig.5: Watson and Benbow grave markers

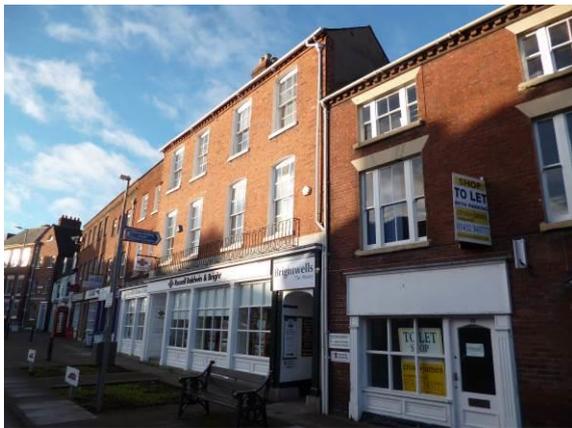
right angles to Broad Street. The river Wye is to the south of the city centre. The meeting house is not visible from King Street and access to it is along a passage off the north side of the street, below late Georgian brick buildings. Facing the passage on the west side is a former town house Number 21a King Street, a late seventeenth century timber-framed building remodelled in the late eighteenth or early nineteenth century (according to the listing). This Grade II listed building is owned by the meeting and let on a long lease for social housing. Other nearby buildings are in commercial use and a car park wraps around the north and west side of the meeting house site. Hereford attracts some tourism associated with the Cathedral, which is set in an attractive leafy precinct.

Fig.6: north side of King Street and the passageway to the meeting house (centre)

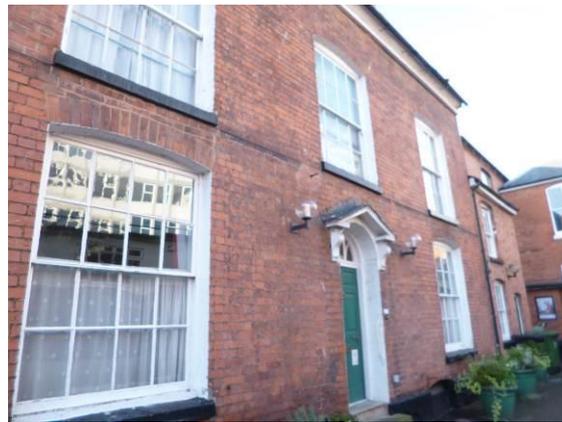
Fig.7: 21a King Street, adjoining the meeting house (just visible to the right)
