Friends Meeting House, Pardshaw

Pardshaw, Cockermouth, CA13 0SP

Statement of Significance

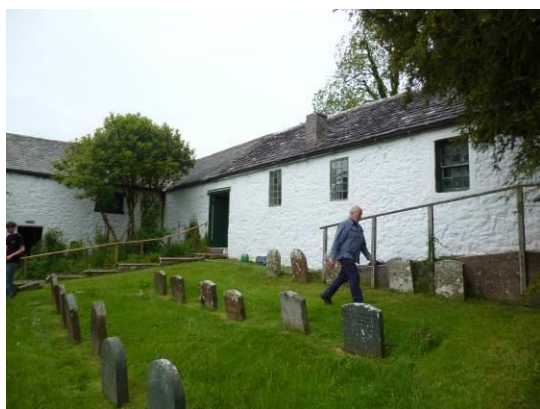
Fig.1: 1745 school room to right and 1731 stables to left, from the east

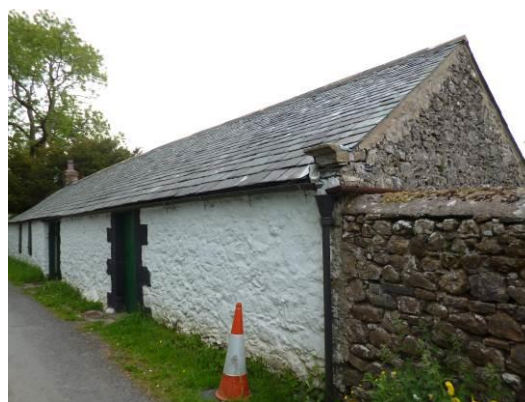
Fig.2: stables (right) and school room from the lane

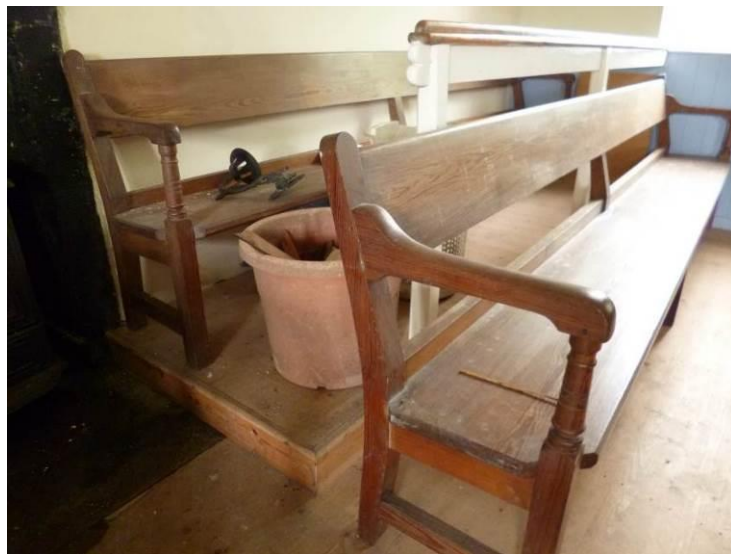
The meeting contains a set of historic pine benches; these have turned upper elements to the front legs and match benches in Cockermouth meeting house. There are also a few plainer benches with solid pine bench ends.

Fig.4: benches and rebuilt stand in the small meeting room

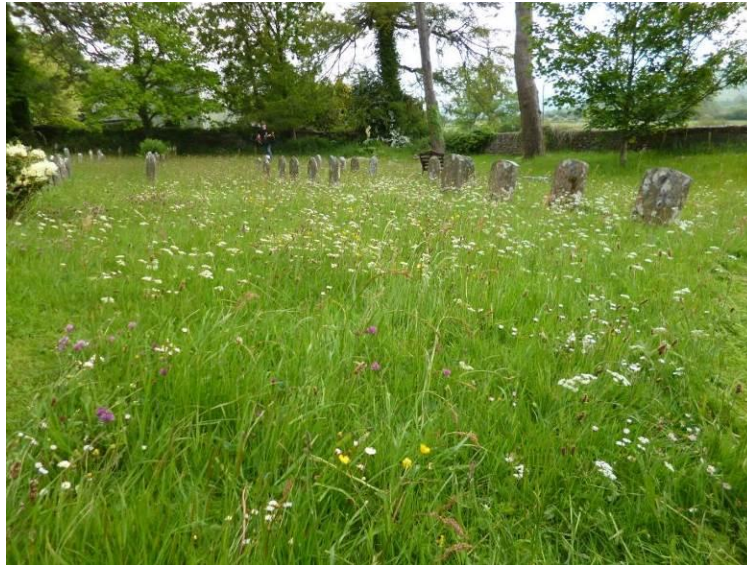
Pardshaw has an attractive burial ground on the north-east and north-west side of the meeting house, which it is still in use. The roughly rectangular area is enclosed by stone walls on three sides, the wall along the lane is higher and has flat stone copings. The burial ground slopes gently down to the south east, giving fine long views towards the Cumbrian fells. There is a raised terrace along the upper side of the area next to the lane; this was probably used as a path between the 1745 and 1774 school rooms. A mixture of mature trees grow along the perimeter.

Fig.5: burial ground from the south-west
