Friends Meeting House, Taunton

Bath Place, High Street, Taunton, Somerset, TA1 4EP

Statement of Significance

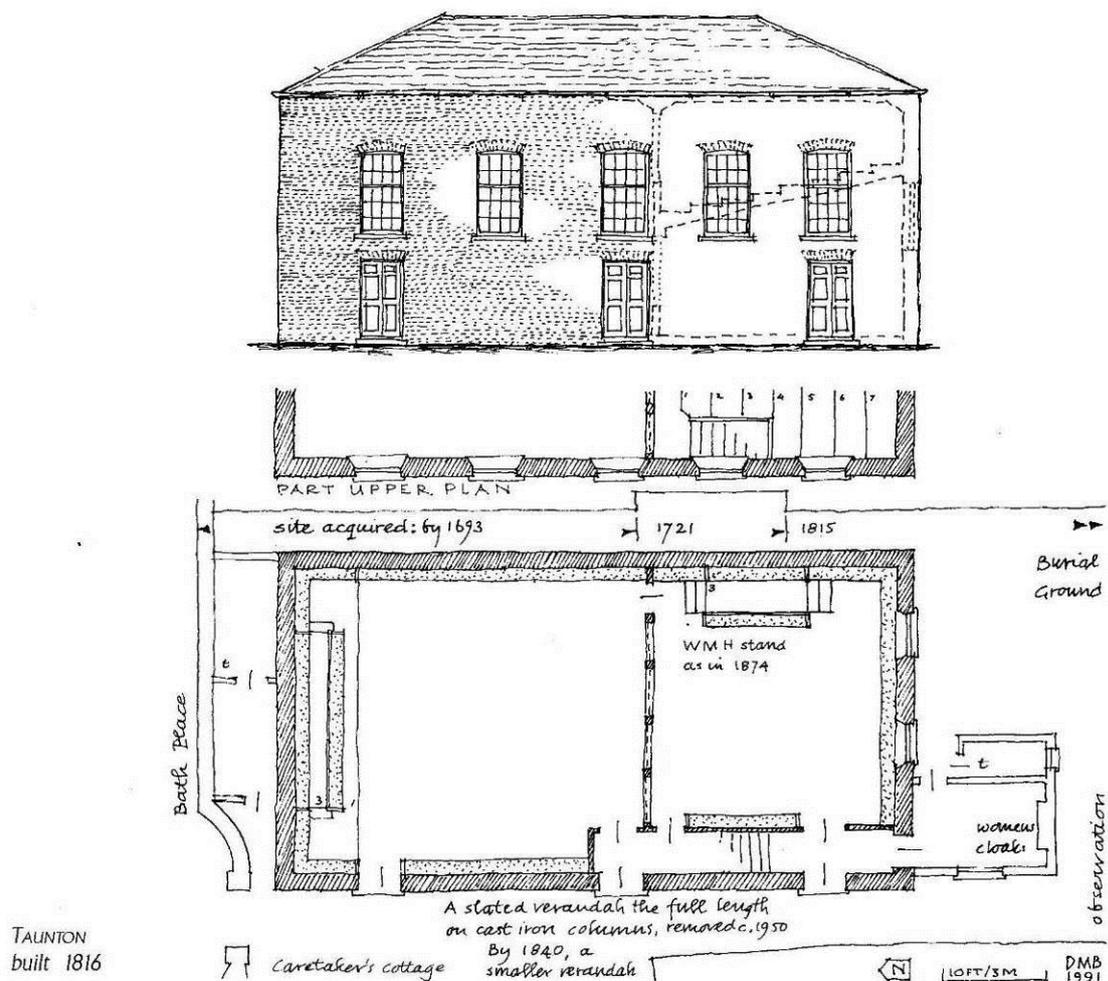
Figure 1: West elevation and original ground plan of the early nineteenth-century meeting house (Butler, vol. 2, p. 549)

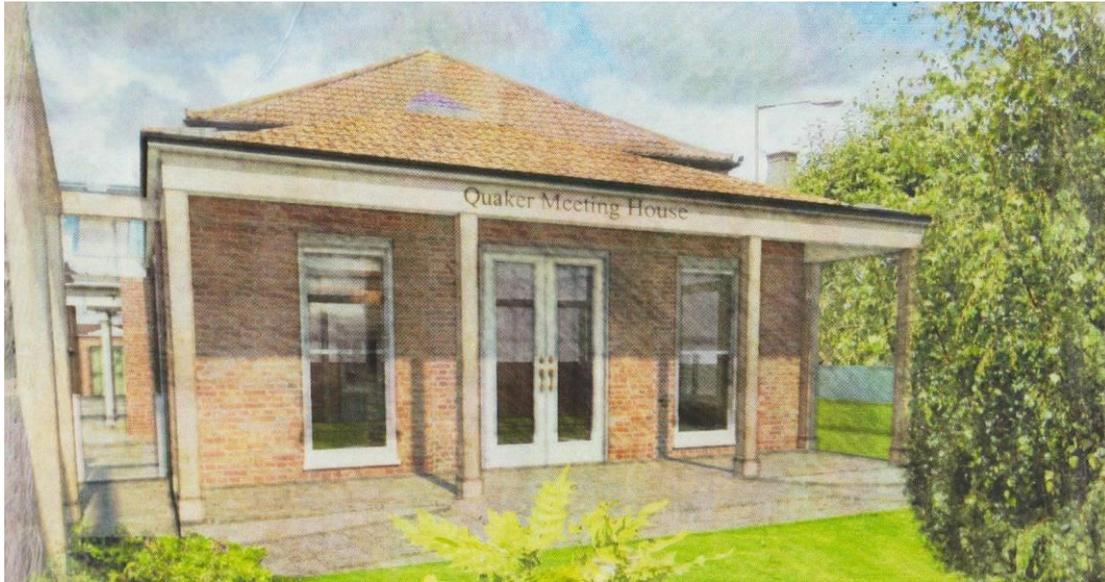
Figure 2: A perspective view of the front of the new meeting house
