## **Friends Meeting House, Watford**

*150 Church Road, Watford, Hertfordshire, WD17 4QB*

### ***Statement of Significance***

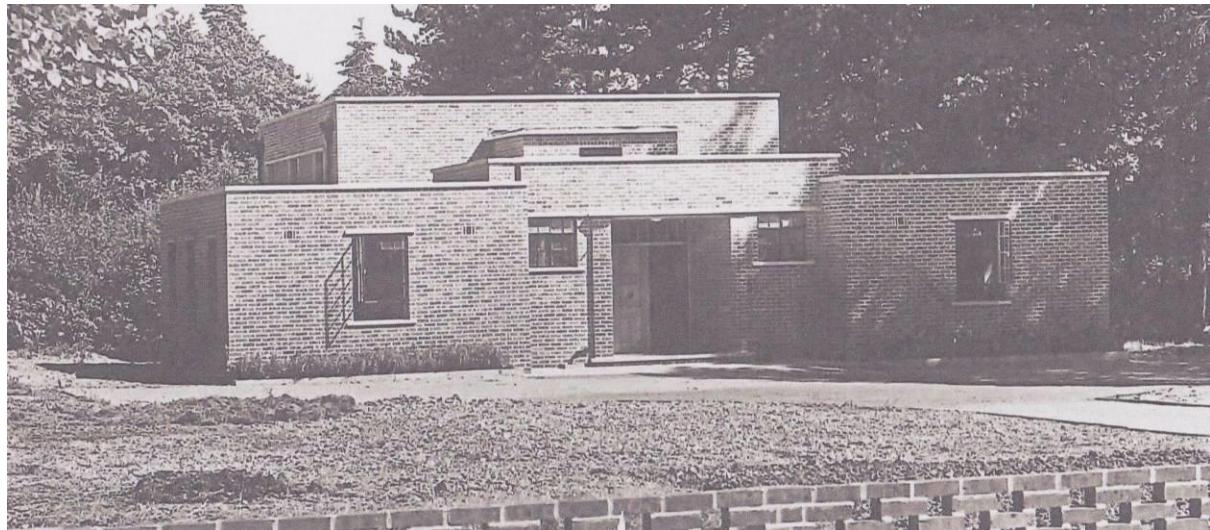
Fig. 1 The new meeting house in 1953 (Local Meeting archives)

Hubert Lidbetter's 1953 building, shown in fig.1 above was a single-storey flat-roofed red brick building designed in a 'modernist' style. A tall square meeting room was placed behind a lower range containing an entrance lobby flanked by toilets and smaller rooms. Apparently Lidbetter prepared designs for an upper storey to be added later, but the commission was given instead to Norman Hyde, who in the 1970s added a new upper storey over the front range containing a warden's flat. The addition had red brick walls and a pitched roof. A second pitched roof was later added over the meeting room. Both the 1970s roofs are covered in concrete tiles.
