Friends Meeting House, Aberystwyth

Maes Maelor, Penparcau, Aberystwyth, SY23 1SZ National Grid Reference: SN 58901 80304

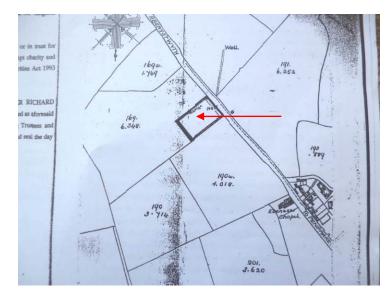
Fig.1: the site of the meeting house prior to the development of housing in Penparcau (Aberystwyth Meeting archive)

The site appears to have been a field prior to the building of the mission hall (Fig.1), and the archaeological potential is probably low.

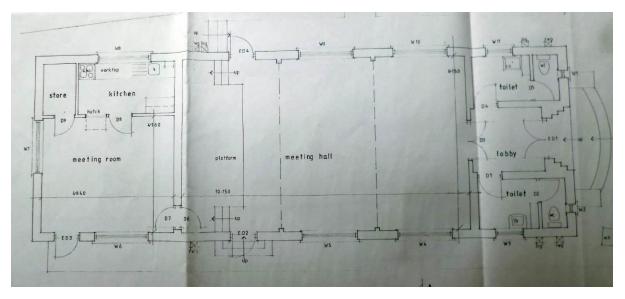
Fig.2: the building in the 1990s prior to refurbishment (Aberystwyth Meeting archive). NB. North is to the top right
