Quaker Meeting House, Bideford

17 Honestone Street, Bideford, Devon, EX39 2DJ

Statement of Significance

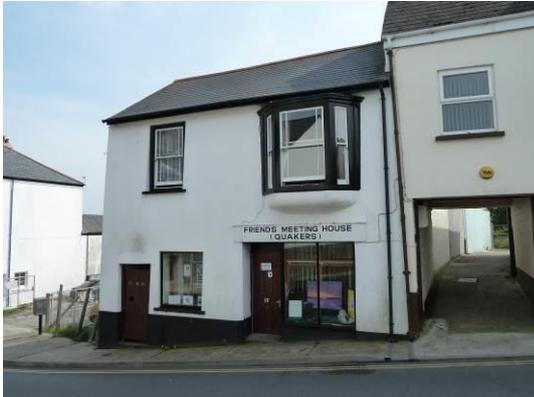
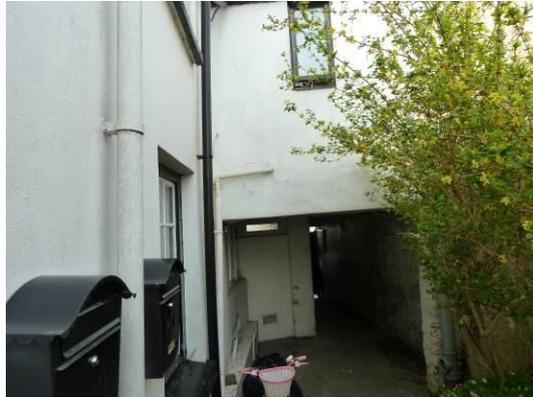
No. 19 and 21 Honestone Street are accessed via a gate on the ground floor of no. 17 (photos top left and right on page 1). The meeting house now occupies a corner site although there was a continuous street line to the east in the 1880s (according to map evidence). By 1904, there was a long narrow cattle market east of no. 15 Honestone Street. (Bideford's Pannier Market was built in 1883-4 on the site of the former cattle market.) By the 1950s, the cattle market had expanded into rear plots to the west. By 1967, some of the buildings on Honestone Street had been cleared for the cattle market, including no. 15. By the 1970s, the cattle market had become a 'training centre'; today, it is used for light industrial businesses and car parking.
