Friends Meeting House, Huntingdon

48a Post Street, Godmanchester, Cambridgeshire PE29 2AQ

Statement of Significance

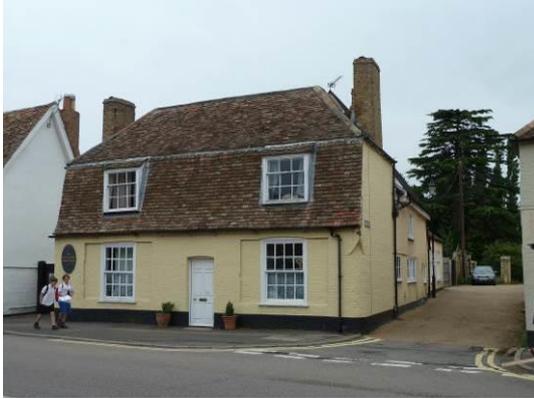
The late eighteenth-century building facing the street (photo top left, p. 1) is built of brick (now painted), with a tiled hipped mansard roof. At either end are brick stacks. The street elevation has three bays: the (modern) entrance door in the centre, flanked by two 8-over-8 sashes (set into originally wider openings), with two dormers above. The south corner is chamfered. The northwest side elevation has a modern side door, a casement window at first-floor level and a window to the raised basement or cellar. The interior was not inspected.

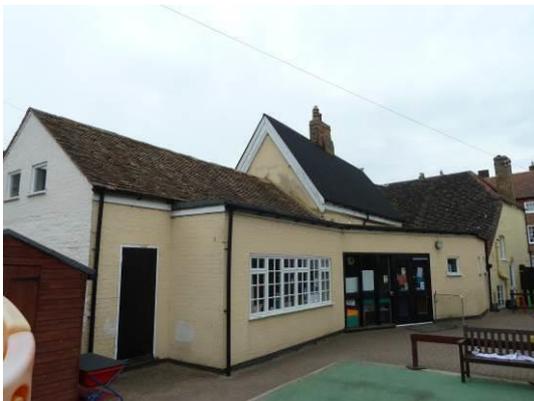
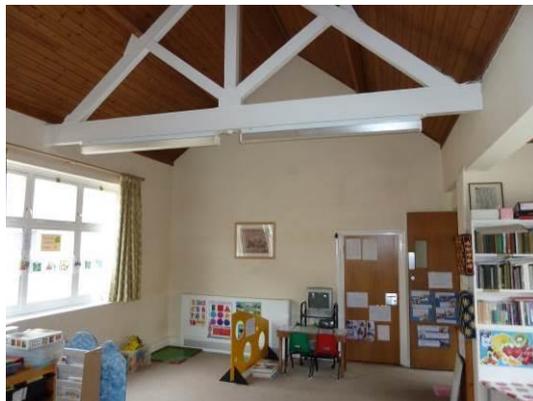
The easternmost rear part of the wing is more difficult to date. It has been suggested that this was built in c.1969–72 on the site of an earlier building but the brickwork looks older. It is a brick structure with a tiled pitched roof. It has two three-light mullion and transom windows to the south and two square gable windows to the east. Internally it is open to the king-post roof and has a timber-panelled ceiling (photo centre right, p. 1). To the north, the former external wall has been removed and the room extends into the 1969–72 entrance block (photo centre left and right, p. 1).

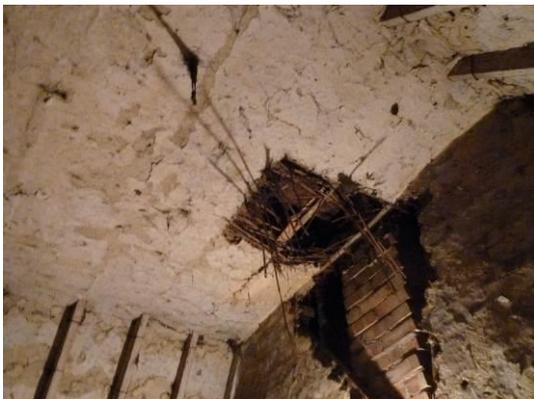
the first floor. The ground floor of this part of the building contains two low-ceiled rooms (one of which has a large fireplace (photo bottom right, p. 1), the other is now the kitchen), both with chamfered beams, as well as a small cellar room only a few steps below ground level. Above are a small first-floor room to the west (used in conjunction with the front residence and not inspected) and an attic on the east side of the central stack; the latter has lath-and-plaster walls and ceiling (the photo bottom left on page 1 shows the attic room to the east of the stack).
