**Kingston Quaker Centre, Kingston**

*Fairfield East, Kingston-upon-Thames, London, KT1 2PT*

**Statement of Significance**

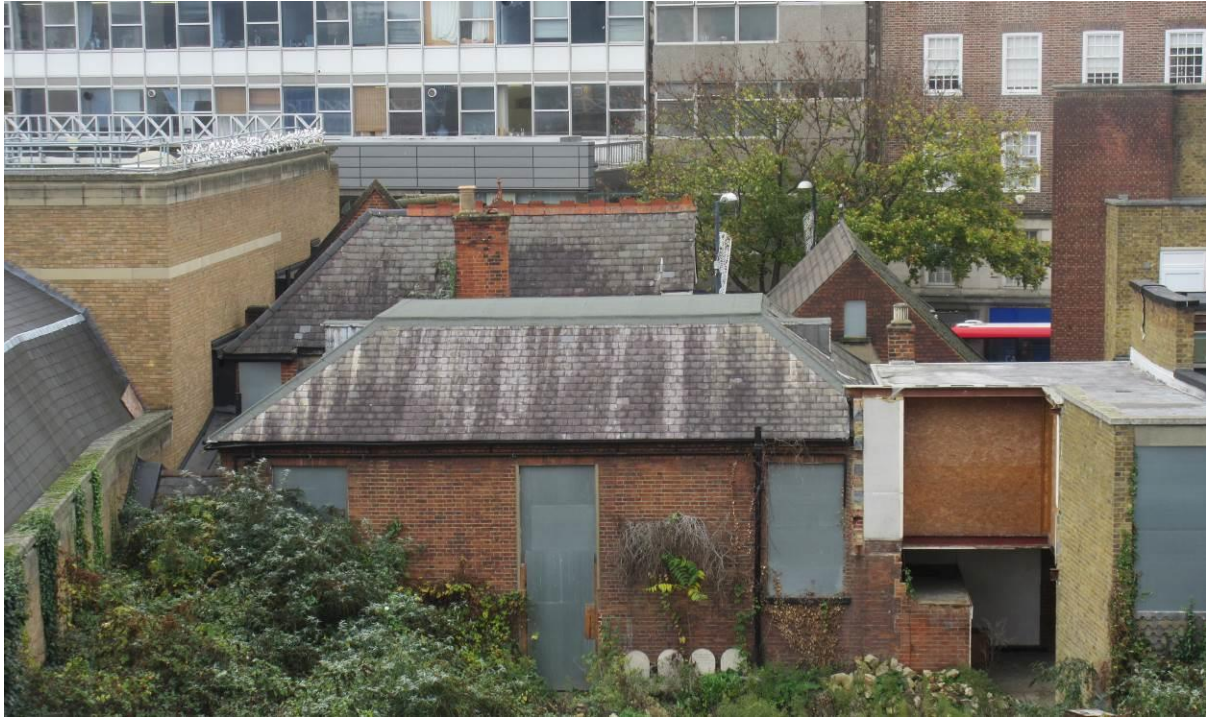
Figure 1: The 1773 meeting house, November 2015

From the late twentieth century there were moves to find alternative premises in the town, and in 2005 a detailed historical report on the 1773 site was prepared by CgMs Consulting in advance of demolition and site clearance. The building was sold by the Quakers and planning consent has now been granted for the redevelopment of the site with a new Primark store, but at the time of writing the building still survives, boarded up, and still with some of headstones in the burial ground (figure 1). The burials were exhumed in 2010 and reburied in Surbiton Cemetery with a memorial stone.
