Quaker Meeting House, Ludlow

St Mary's Lane (off Lower Corve Street), Ludlow, SY8 1DZ

Statement of Significance

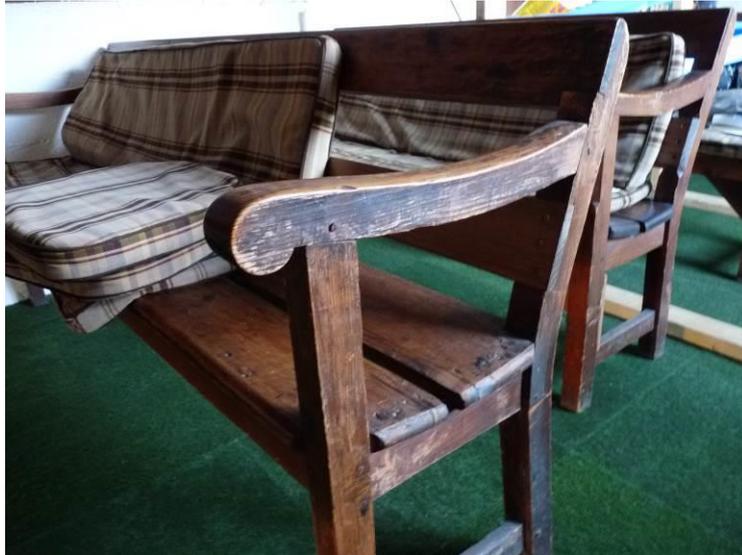
There are some historic pine benches in the gallery; these are probably of nineteenth date and brought here from another meeting house. In the small meeting room there is a mid-twentieth century oak barley-twist gate leg table, and in the Meeting Room, a more recent table probably made by Garth Reynolds.

Fig.1: historic pine benches in the gallery
