Friends Meeting House, Marsden

21 Walverden Road, Nelson, BB9 oPJ National Grid Reference: SD 85651 36462

Statement of Significance

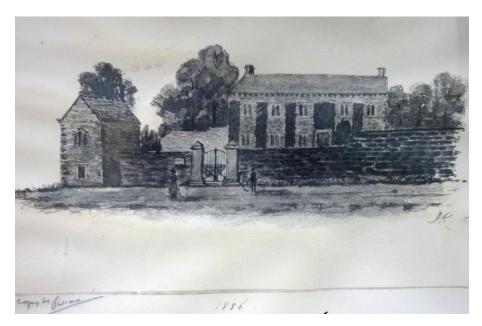
Figure 1 A wash drawing of the meeting house dated 1886, prior to building the 1909 schoolroom (Marsden Meeting)

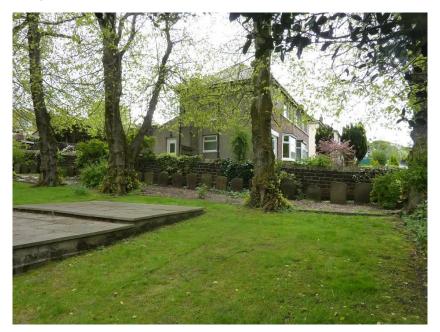
The attached burial ground survives on both sides of the building, enclosed by stone walls and retaining mature trees. Headstones have been removed at the front and have been re-set along the site boundary. A few *in situ* stones survive at the back of the building. The inscriptions, with dates between 1834 and 1978, were transcribed in 1981 and copies are available at Burnley and Colne libraries.

Figure 2. The burial ground with repositioned headstones.
