## ***Friends Meeting House, Preston Patrick***

*Preston Patrick, Milnthorpe, LA7 7QZ*

### **Statement of Significance**

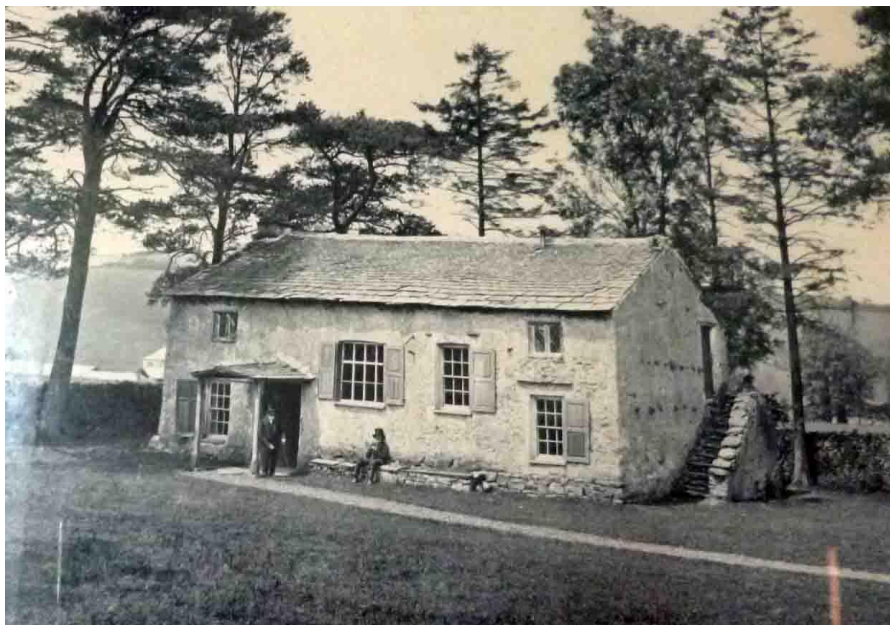
Fig.1: undated 19<sup>th</sup> century photograph, by J.H.Hogg, of the meeting house built in 1691 (framed photograph in Preston Patrick meeting house).

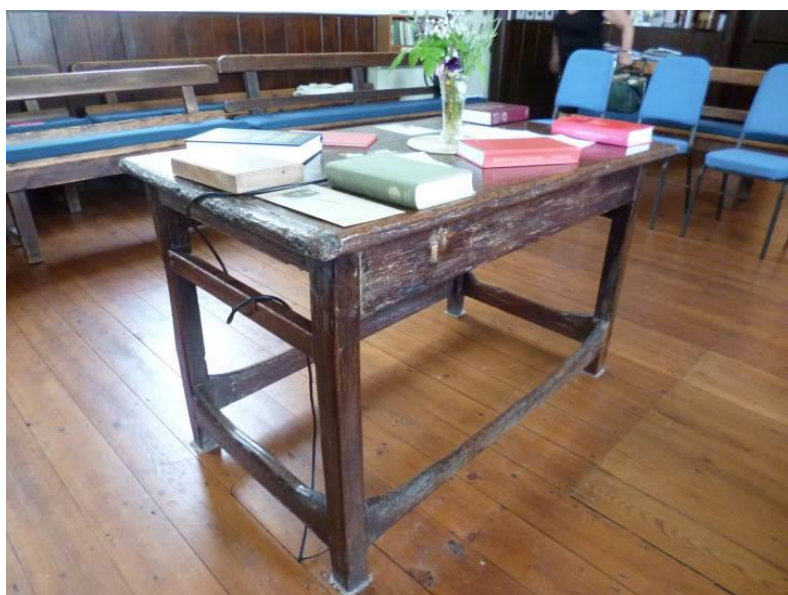
The meeting house contains a set of around a dozen pine benches which appear to be nineteenth century, arranged around the edge of the room, with a plain oak eighteenth century table in the centre of the room.

Fig.4: table and benches

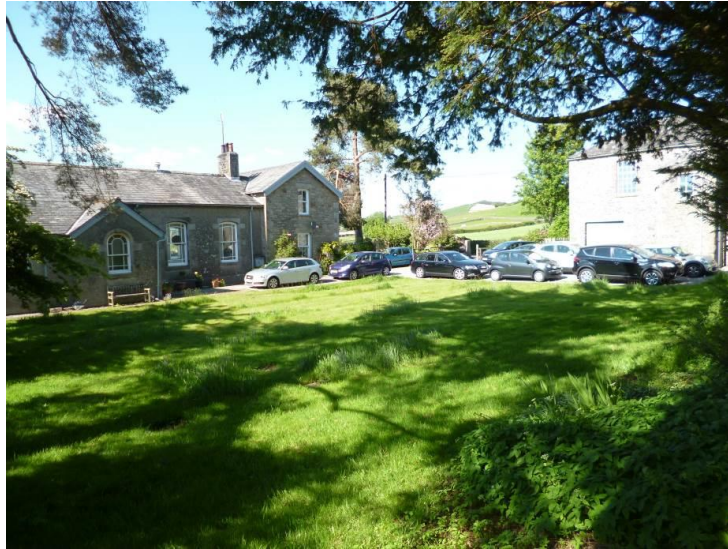
The burial ground lies on the south side of the meeting house and slopes up to the south boundary wall. The rectangular space is enclosed with drystone walls, with pine trees to the south side and a gravel parking area to the north alongside the meeting house and former gig house. Gravestones are laid flat in the grass and there are no standing headstones. The burial records are held in the strong room at Kendal Friends Meeting House, with copies at the Preston Patrick meeting house; the earliest burial is thought to date from 1685.

Fig.5: view from south-west across burial ground with meeting room to left and former schoolroom to right

- i) Meeting House: Good. No QI has been carried out recently.
- ii) Attached burial ground: Optimal/generally satisfactory. The grass is regularly mown and well-maintained by the meeting. The visual character and tranquillity of the burial ground is partly affected by car parking for the office user in the former school room.

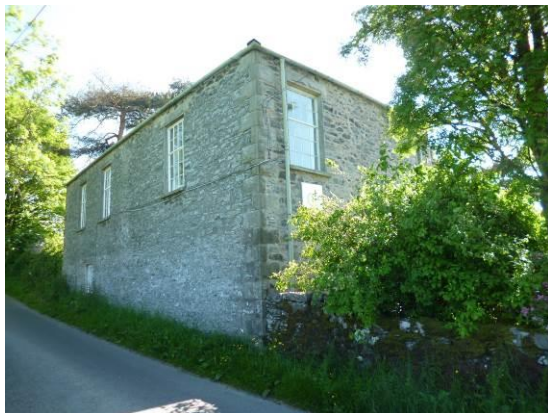
Fig.2: school room, now office, from the lane

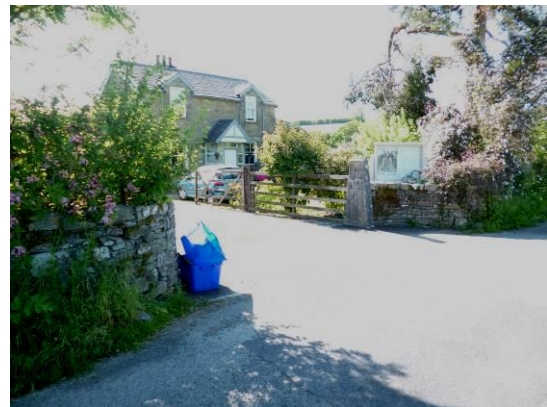
Fig.3: entrance and cottage from the lane
