Friends Meeting House, Woking

41 Park Road, Woking, Surrey, GU22 7DB

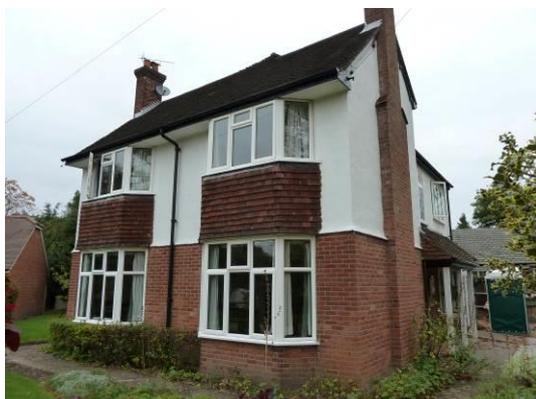
The entrance elevation faces southeast. The two-storey house has a short T-plan with two gable roofs. The materials are brick laid in stretcher bond, with a rendered first floor, and a tiled roof. Most windows and doors have been replaced in UPVC. The southwest elevation (photo top left, p. 1) has two two-storey canted bay windows with tile-hanging between the floors. The entrance (southeast) elevation has a brick chimneystack against the gable and a lean-to canopy over two entrances, which include the original timber door with a stained glass panel as well as a UPVC door. There are two first-floor windows above: one of UPVC, the other original and repeating the stained glass motif. The northwest elevation has another gable end with a chimneystack, beside a door under a bracketed hood, as well as three
